NDT FOR THE CHARACTERIZATION OF A MONUMENTAL BUILDING OF THE FIRST HALF OF THE 20th CENTURY: THE OSSUARY TEMPLE OF BASSANO (ITALY)

Dario Foppoli, *Foppoli Moretta e Associati, Tirano (SO) – Italy, posta@foppolimoretta.it*
Alessio Caligari, *Foppoli Moretta e Associati, Tirano (SO) – Italy, posta@foppolimoretta.it*

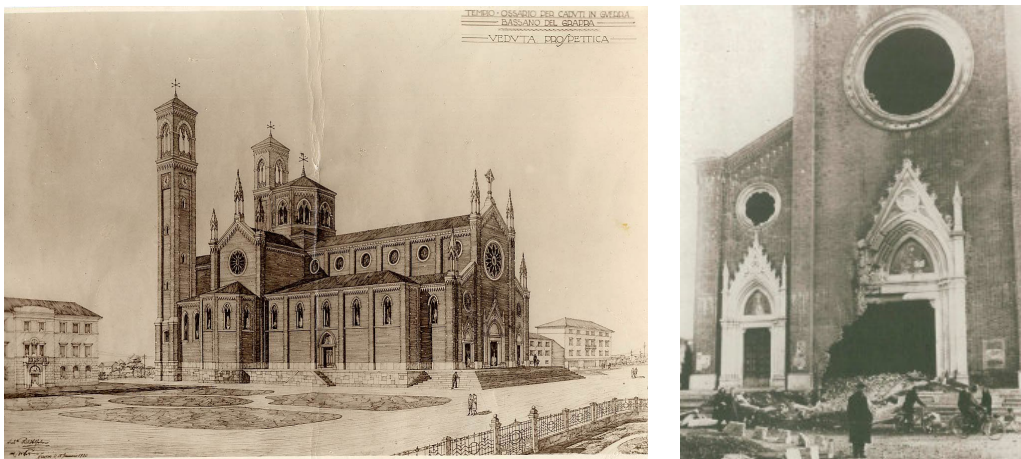
**Figure 1 Prospective view drawn up by architect Pietro Del Fabbro (1930),
The effects of World War II bombings on the temple facade**

During the Second World War, the Ossuary suffered damage (Fig. 1) due to the bombings that completely destroyed the close-by Victory Bridge; the damaged areas were restored in 1948 and in 1951; during the following years, atmospheric events caused the fall of some pinnacles on the crowning of the façades, which were therefore removed.

the extrados. The external surfaces of the walls are completely made with brick masonry with no noticeable discontinuity, except for the traces of the repairs of the damage caused on the main facade by the war (Fig. 1).

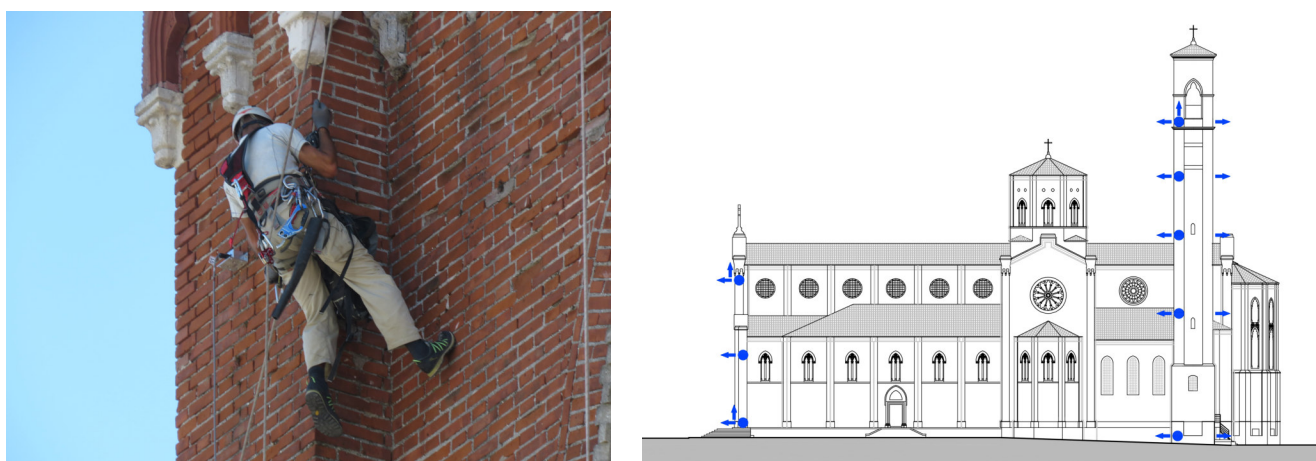
Figure 2 Placing of the sensors with rope access techniques, sketch of sensors position

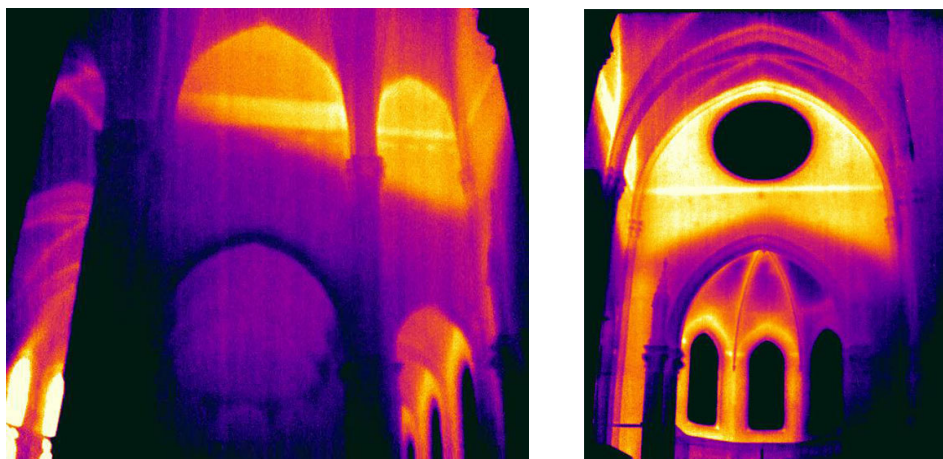
Figure 3. Thermography of the south side and west side of the western transept

For the purpose of localization of wet areas, the abnormalities of negative gradients (colder areas) were located and analysed. Thermal analysis of thermograms, comparison with the conservation status of the surface and analysis of the environment allowed the evaluation of the typology of detected anomalies. In areas that were at a lower temperature and in areas of evident degradation, samples were also taken to carry out gravimetric measurements and analysis of soluble salt content.

Through the thermographic survey, some significant information about the construction techniques were obtained. In the two transepts, for example, the presence of linear high thermal conductivity elements embedded in the masonry body (Fig. 3) were evident: on the basis of subsequent surveys carried out by endoscopy and electromagnetic analysis, the horizontal element, 100 cm in height, was identified with reinforced concrete beam, and its geometry and structural rebars were exactly detected. Other punctual thermal anomalies visible in the same images should be correlated with the unusual presence of stone elements embedded in the masonry.

The comparison with the shots recorded in April 2009 confirmed that the roof restoration works carried out in 2011 removed the meteoric water leakages. Only few spots, however circumscribed, can currently be regarded as wet: their humidity was confirmed by gravimetric measurements, specifically in the samples taken on the inner surface of the lantern and on the inner surface of the main facade close to the portals. On the wall of the nave, on the contrary, the leakages that in the past caused the wide-spread spots are currently exhausted, as confirmed by the thermographic shots further supported by gravimetric measurements.

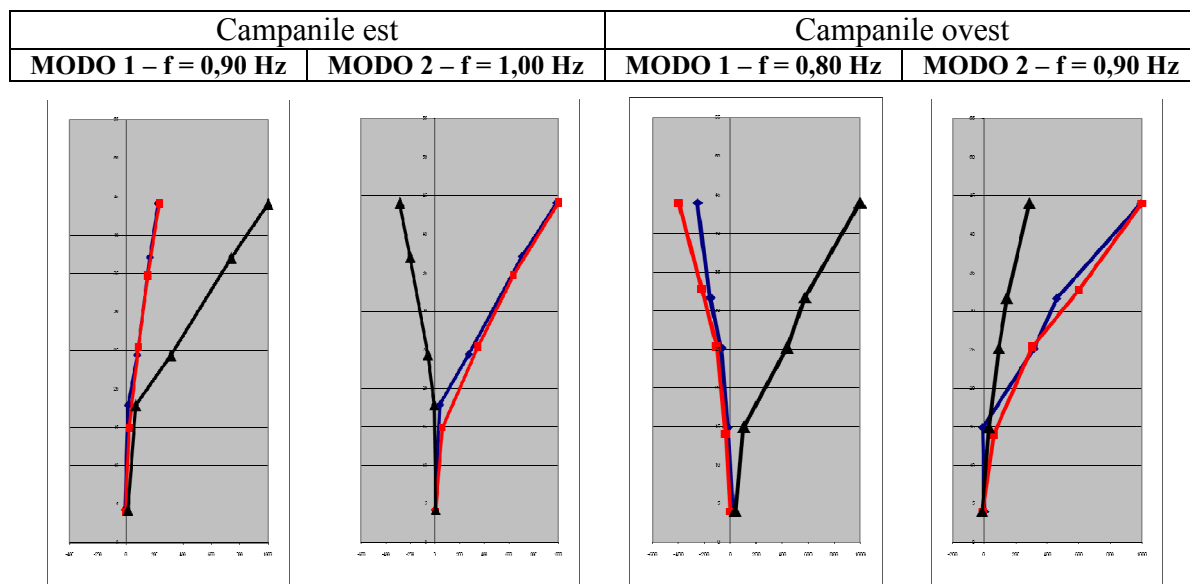
Figure 4. Modal diagrams of the prime two vibratory modes of the two bell towers

The analysis was able to compare the dynamic behaviour of the two bell towers that are quite similar because of their geometry and boundary conditions. The analysis has been done taking into account 250 Hz sampling in both the cases; the recordings made with and without the movement of the bells were analysed separately. Thus, it was possible to detect the top five vibratory modes of each bell tower; which, while not having equal frequencies, correspond with regard to the type of vibration.

The analysis of the distribution of detected vibration frequency content shows that bells mainly respond to environmental noise factors in the first two ways of vibration, while being less sensitive to other frequencies. Modal diagrams (Fig. 4) show that movements are prevalent in horizontal directions.

Modal parameters of the detected modes are estimated with sufficient precision (the coherence values in the determination of the transfer functions are generally good, that means above 0.85, for the East bell tower and are lower for the West bell tower). The horizontal modal diagrams are regular. It is necessary, however, to underline the high values of modal damping (for the top two vibratory modes it is, respectively, 4% and 5% for East bell tower and 3,5% and 3% for West bell tower, while for the following modes it is always lower than 1,5%). This is meaningful if we take into account the low excitation level applied during the measurements: in this condition such factors (low coherence value and high modal damping) contribute to indicate an abnormal behaviour, especially for the West bell tower.
