## From Palladio to Reinforced Concrete: NDT Applied to the Old and the New Bridge of Bassano del Grappa

Dario FOPPOLI

Foppoli Moretta e Associati s.r.l., v. Damiani, 2, 23037 Tirano (SO) ITALY

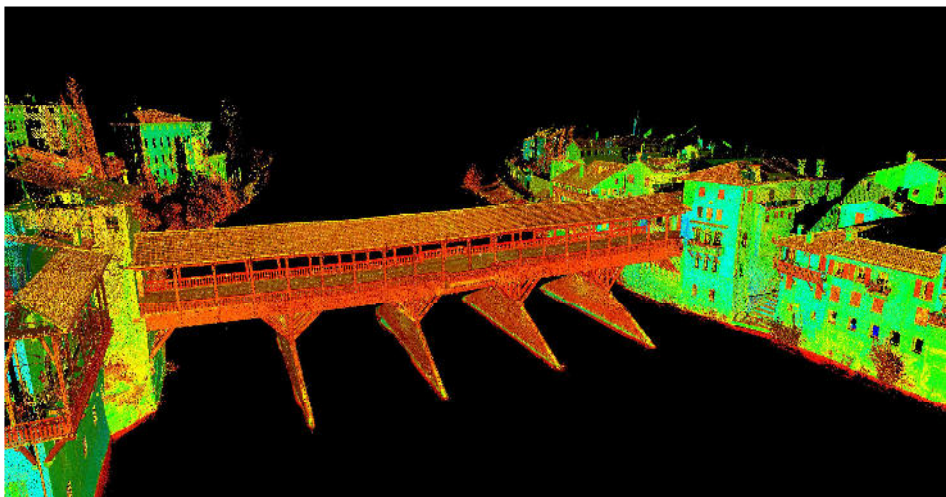
Figure 2: Image of the point cloud obtained by laser-scanner

Geometric irregularities found in both deck and piers have allowed the vertical overall deformations to be traced. Deformations of the existing paving are visually clear and it is reasonable to think that they developed after the last refurbishment in 1992. Their measurement has allowed an estimation of the current deformation pattern at the extrados of the deck, which can also be confirmed by the way the piers planks have deflected. In this case too, it is reasonable

to assume that originally (in 1990-1991) the planks were laid with horizontal level, and the detected geometric irregularities are therefore indications of absolute settlement of the piers after this date. In fact, the sets of measurements converge, providing a reasonable estimate of the absolute settlement of the structure, with maximum displacements of 35-41cm at the extrados of the 2<sup>nd</sup> pier.

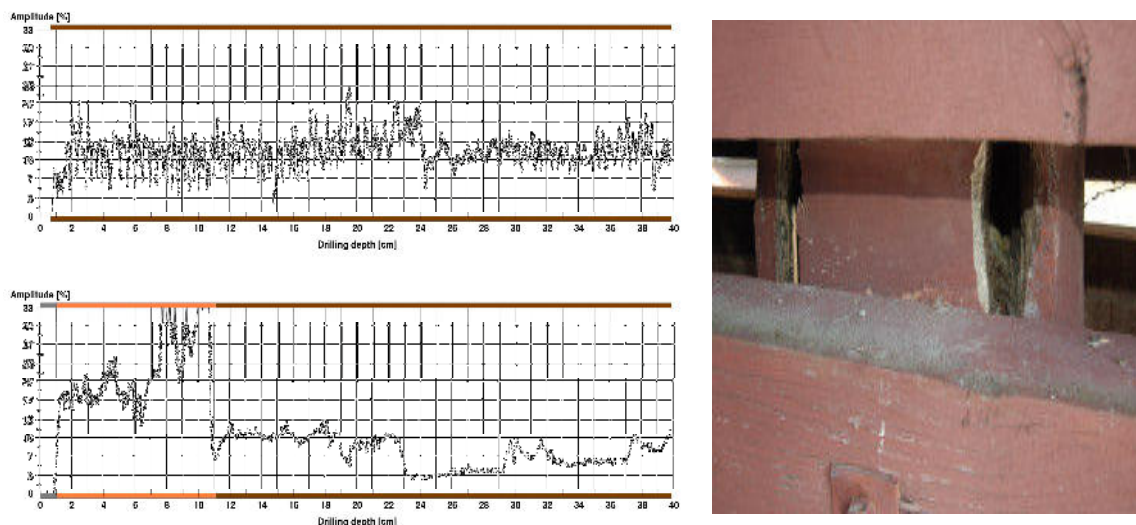
Figure 3: Drilling diagrams; decay on the wood-resin interface

Visual inspection was key to accurate identification of the various strengthening works already carried out in the past (metal supports and timber board supports, resin with sand casts), but also to assess the level of timber decay and, in some cases, the poor effectiveness of the strengthening interventions which caused further deterioration (Fig. 3). Resistograph tests [4] provided significantly different diagrams for the timber located well above the seasonal variations of the river level and the timber directly subjected to wet and dry cycles (Fig. 3). In the latter case, it is

not possible to identify with certainty the variations in density between summer and spring timber areas, indicating a significant morphological variation of the timber itself. To identify the wooden samples macroscopic examination was performed using dichotomous keys existing in literature, which identified the wood species of the struts (*larix decidua*) and of the pile constantly immersed in water (*quercus petraea*) according to the traditional use in the Veneto region.

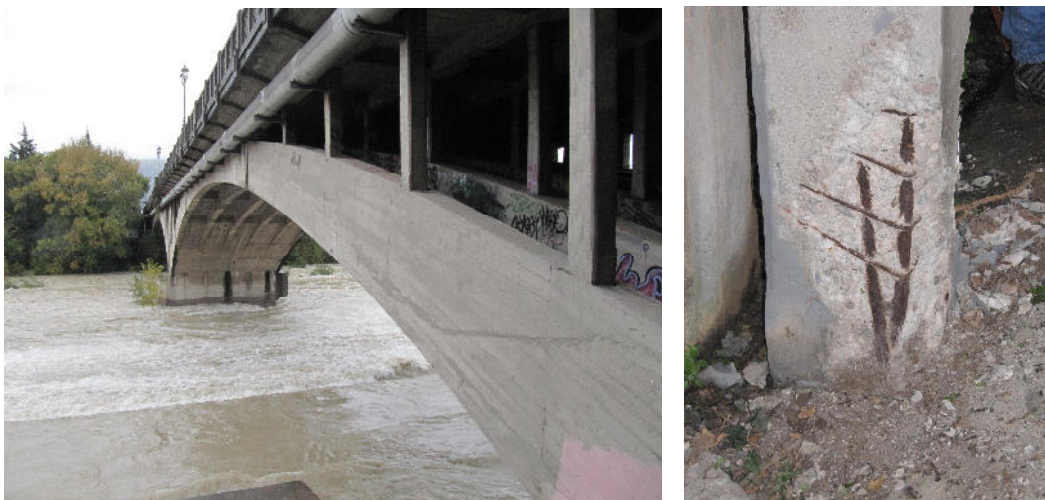
Figure 5: Downstream arches seen from left-hand side abutment; substantial concrete loss of mass

Pillar stirrups are occasionally irregular and look systematically more exposed on the corners, which are generally rounded off. Beams and joists at the intrados show extensive exposure of stirrups and sometimes of longitudinal bars as well. Consequently, there are some cases of considerable surfacing, oxidation and sizeable concrete spalling (Fig. 5).

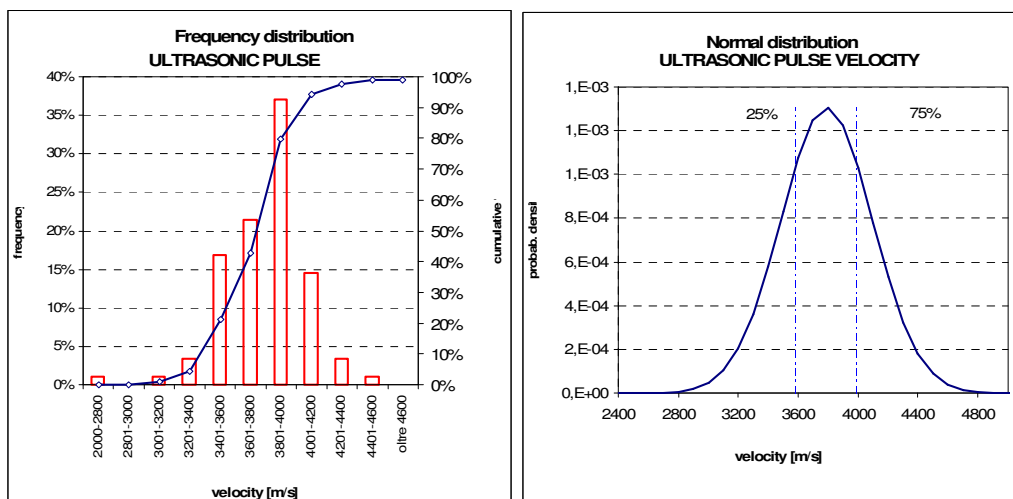
Figure 6: Frequency distribution and normal distribution of ultrasonic pulse propagation velocity

Measurements of ultrasonic pulses velocity (UT) provide values resulting rather homogeneous within the same typology of structural members, with the average speed values for arch, beams and joists respectively of 4051m/s, 3659m/s, 3508m/s. Topographies of some arch (TS) were performed by measuring sonic pulse velocity and were used to evaluate the section homogeneity. They show a significant dispersion of velocity values within each section, confirming the rather poor concrete compaction during casting already highlighted by the dispersion of carbonation values.

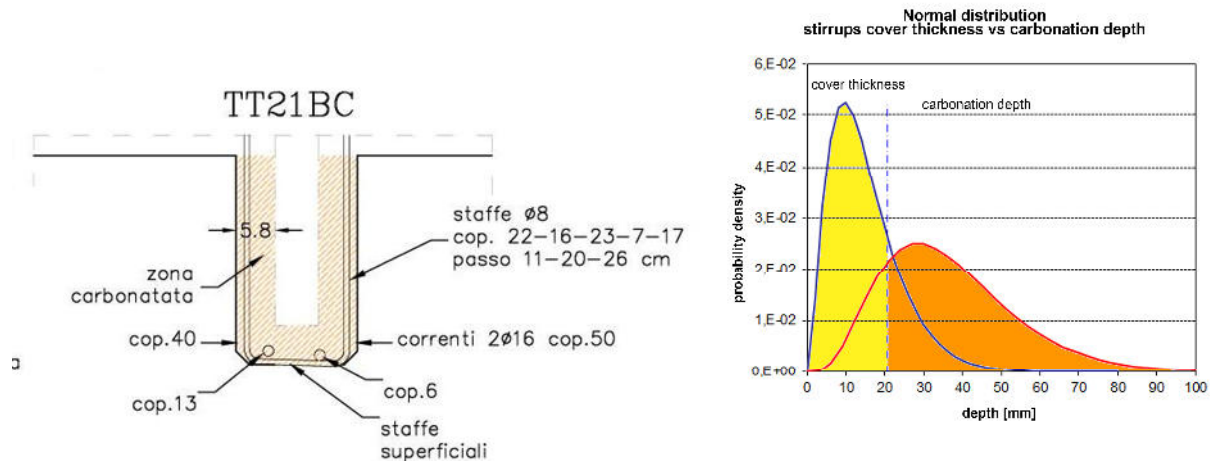
Figure 7 Sketch of carbonation in some structural members; normal distribution cover vs carbonation depth

Since the most relevant carbonation effect is to expose the reinforcement bars to oxidation, carbonation analysis have to be compared with the cover depth to evaluate any damaging effects. As clearly shown in the typical pattern of some of the analyzed structural members (Fig.7), in several cases at present, the concrete carbonation front has advanced beyond the stirrups cover depth: consequently the rebar lies in an environment which allows their corrosion. The resulting increase of volume causes cracks to open and cover to detach. This consideration can be statistically substantiated by comparing the frequency distribution of both stirrups cover and carbonation depth (Fig.7). Their comparison shows that the carbonation depth detected in the analyzed structures represents a significant factor in rebar deterioration.

The same can be underlined observing the longitudinal bar cover, highlighting how these bars also suffer from the same relevant oxidation problem.
