CHARACTERISATION OF DIFFERENT MATERIALS AND CONSTRUCTIVE TECHNIQUES OF HERITAGE BRIDGES IN THE NORTHERN ITALY

Dario Foppoli
Foppoli Moretta e Associati
via Albonico, 17
23037 TIRANO (SO)
ITALY

KEY-WORDS: Masonry bridge, wooden trussed bridge, heritage bridges, investigation, case study

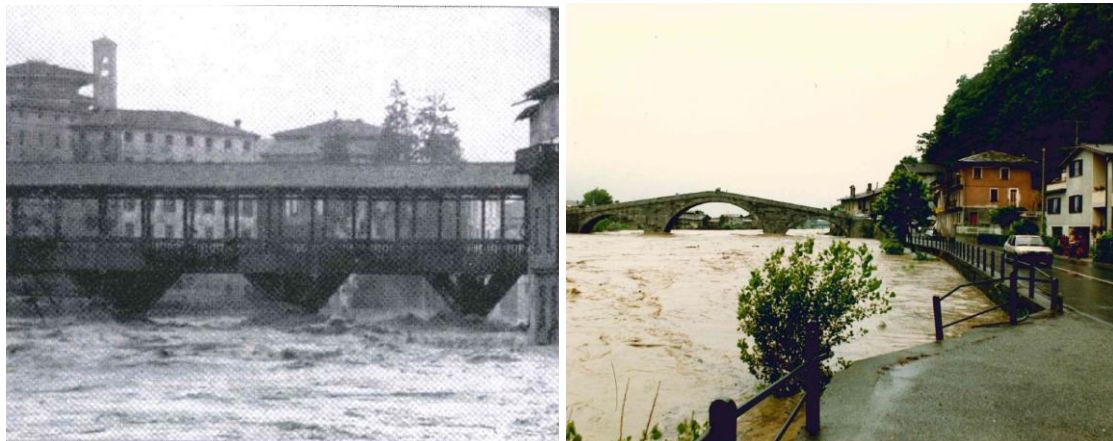
The last destructive flood took place in 1966, when the bridge was seriously damaged curving downstream because of the load of the water and again requiring important repair work.

*Fig. 3 pictures of Bassano bridge during the flood of November 1966
and Ganda bridge during the flood of July 1987*

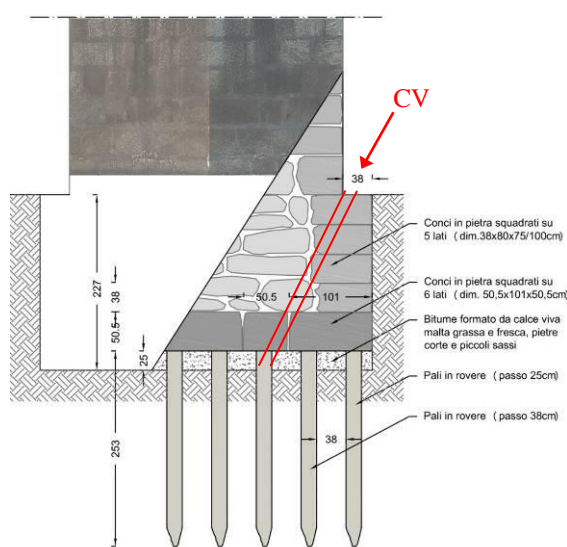
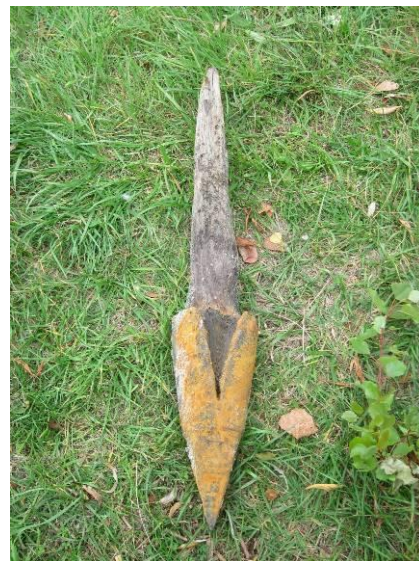
Fig. 6 foundation construction in compliance with the "Chapters"; sample of nailed poles recovered at Bassano bridge site (XVI-XVIII century)

The actual foundation asset greatly differs from that prescribed in the "Chapters". It is not clear how the right column was constructed following the declaration that it was built on a "sounding rock". On the left column, where corings were carried out, in agreement with the diagnostic results, masonry is haphazard and not following guidelines: mortar of bad quality was used with stones and lumps of brick. Abundant water leaked from the bore hole showing the great amount of cavities that allow water filtration inside the structure. While reaching through coring the maximum depth possible (as indicated in the "Chapters") it wasn't possible to recover cores from the foundation stones; conversely wooden fragments from the poles were recovered proving their use in foundation reinforcement.

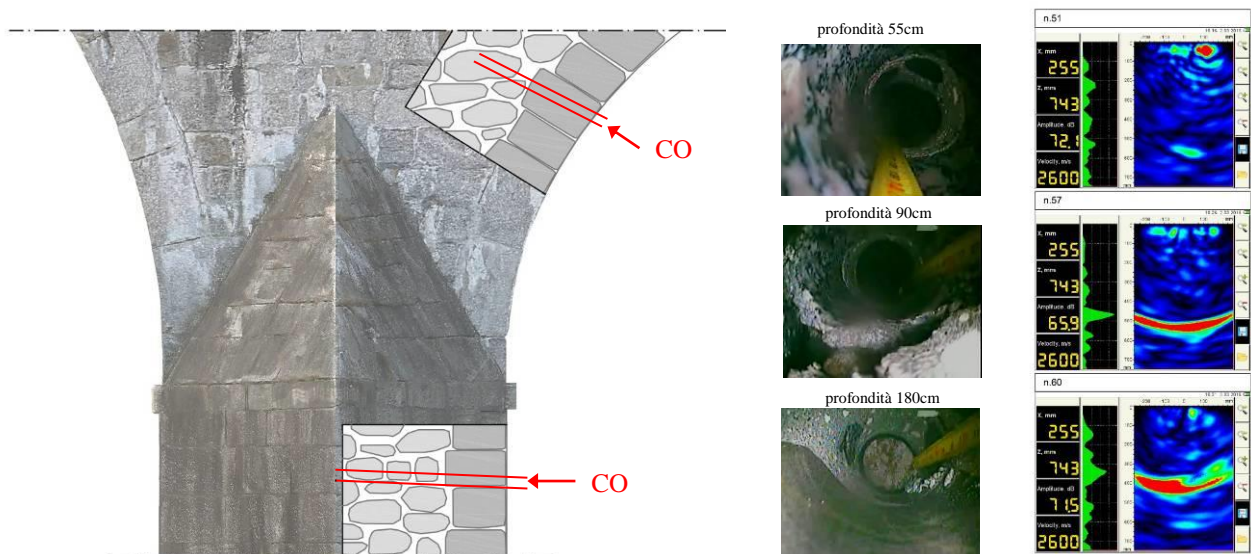
The masonry of the right pier has the external layer made with squared stones (mainly "serizzo" and "ghiaandone" – types of local stone) taken out from quarries placed not far from the construction site; the infilling is made of compact masonry, made with stones with lower dimensions, 20-40 cm (Fig. 7), probably picked up from the river bed, and mortar with good quality and adhesion characteristics.

Coring allowed detecting half the thickness of the pier (that means the whole thickness of the same because it can be considered symmetric). The good texture detected enables to suppose that the masonry also in this case was built in compliance with the "Chapters", that is with uniform horizontal layers, built for the whole section including the spurs of the bridge. Only the cusps above the spurs seem not to be properly connected to the masonry body. The surveys performed also led to acquiring information on the abutments, that were constructed with similar care.

Fig. 7 a pile as prescribed in the "Chapters"; images coming from coring holes inspected with endoscopic video camera and tomographies on the outer stone layer

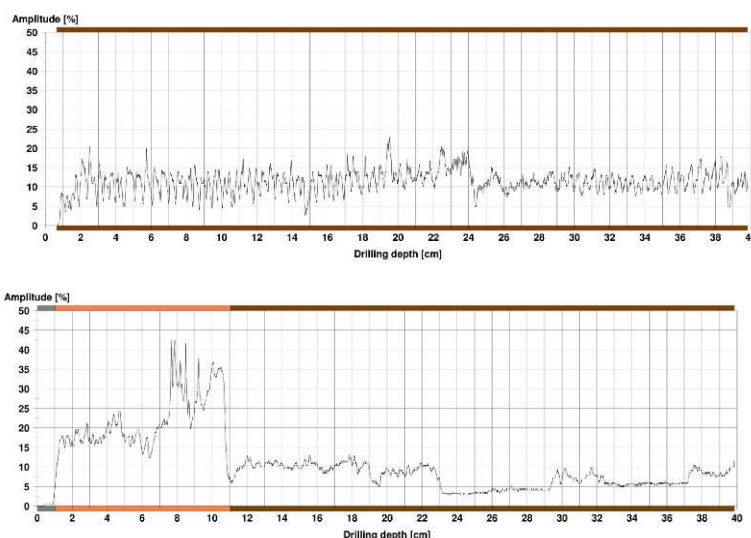
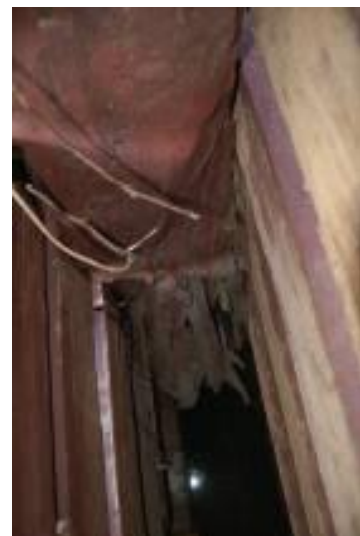
Fig. 8 drilling tests at lower and higher level of the structure, evidence of the decay of the wooden section at the base of the poles

Almost all the wooden poles are cracked at the centreline, perhaps because of the holes drilled to insert the threaded bars connecting the planks. Systematically within these cracks, extensive decay phenomena have developed, generally connected to the growth of wood rot. It was also noted that where the past reinforcement with cast resin has been employed, detachment between the resin and the wood at contact edges has occurred. Presumably, this phenomenon is consequent to the cyclic wet-dry expansions due to changes in the water plane of river. These slots result in a preferential trend of wood rot penetration, thus causing the growth of the decay phenomena. In correspondence with the second pier it was also possible to observe the complete decay of the lower part of the poles within the planks (Fig. 8).

In order to analyze the elements for which signs of deterioration are not visible, the inspection has been integrated with instrumental techniques. Tests found significantly different values of drill resistance between the timber put in place at higher level and the one that is directly affected by variations of water level (Fig. 8).

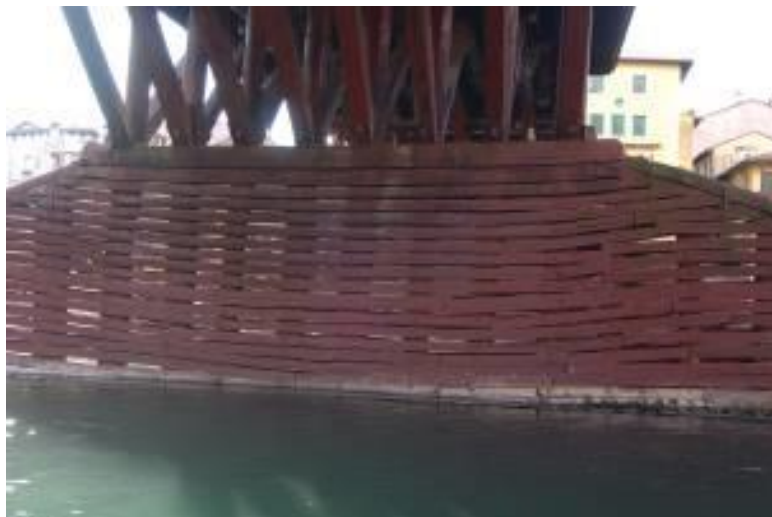
In spite of the many interventions previously described that have occurred over the last century, Bassano bridge at the time of the inspection, presented signs of major settlement that caused concern for its structural safety. They were mainly highlighted by the deformations of the piers (Fig. 9) and by the out of plane of the road deck.

Fig. 9 the loss of horizontality of the planks of second pole shows the settlements of the poles

current outline of deformation at the extrados of the bridge's deck. Feedback can also be sought by observing the strong deflection of the planks covering the piers. In this case too, it is reasonable to assume that in 1990-1991 works the planks were put in place with a proper horizontal alignment, so their current geometrical irregularities indicate absolute settlements suffered by the structure after that date. In fact, the measures thus obtained on the deck and on the piers converge satisfactorily providing a reasonable estimate of the very relevant absolute failures of the structure, with maximum values of 35 cm for the second pier.

This intervention was carried out during winter 2015 and it allowed to considerably reduce the dead load on the deck, to stop the settlements of the bridge, as confirmed from the diagrams of fig. 10: in same case, as resulting from section B, the deformations following the intervention proved to have the opposite position (upward) than the previous ones due to the elastic recovery of the deformation of the wooden beams of the deck, when lightened by the significant load of the superposed pavement.

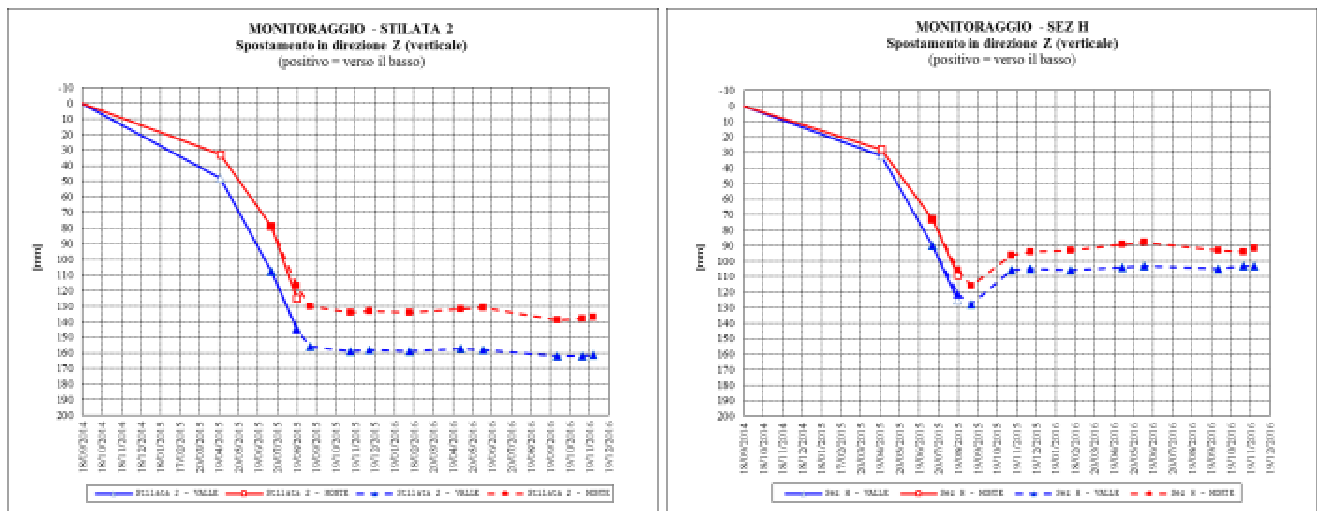
Fig. 10 monitoring diagrams

The measurements were performed through a "topographic total station" Leica TCRA 1201 with precision 1" that allows detection displacement of the target in three orthogonal directions. From the diagrams in Fig. 10, it is evident that the monitoring data immediately highlighted serious settlements: in the first period it proved to be in incremental evolution, with settlements up to 15 cm over 12 months at the second pier. This situation suggested proceeding immediately with the execution of urgent works to guarantee the safety of the bridge, starting from the removal of the heavy stone pavements on the deck.

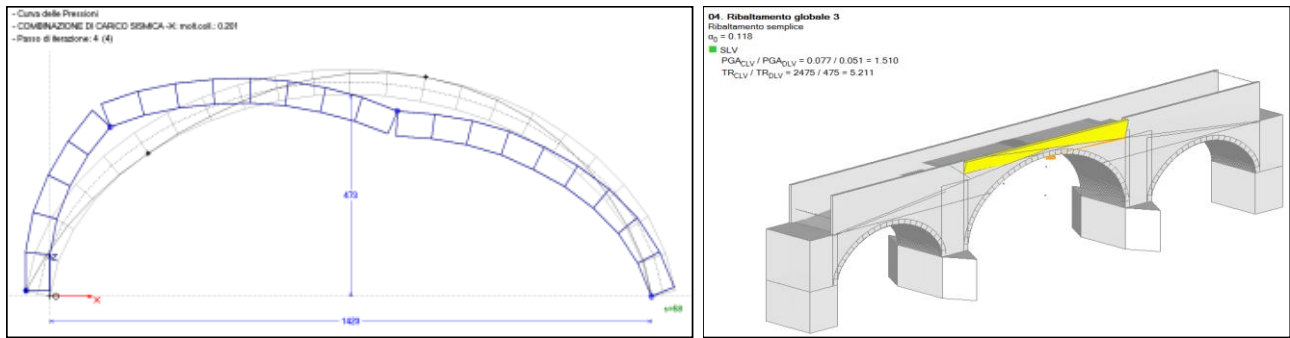
Fig. 11 2D model – kinematic analysis;
3D model – macro-element analysis for seismic risk factor evaluation

Seismic analysis of each arc was carried out using the kinematic approach to define the collapse configurations of the arcs and the seismic risk indicators associated with them; each arc was compliant with the requirements of the standard. The further verification of the collapse mechanism was carried out. This analysis highlighted the structural elements (macro-elements) sensitive to out of plane structural behaviour: each significant local collapse mechanism was examined, and also in this condition the results assessed the adequacy of the bridge.

It has to be noted that, while the analysis are positive if referred to the stability (fundamental element) and to the friction, the compression strength values used for the masonry do not reach a good index. However these values were taken from the tables of the codes, that proved to be highly conservative (Foppoli, 2016) especially if referred to regular and compact texture masonry like that of the Ganda Bridge. In this case, it is therefore advisable to deepen the level of analysis through specific tests to determine the effective strength of the masonry; subsequently to reformulate the evaluation in a more precise way on the basis of the data thus obtained.
