# Characterisation of Different Materials and Constructive Techniques of Heritage Bridges in Northern Italy

***Structural Faults + Repair-2018 &  
European Bridge Conference-2018  
Edinburgh, May 15<sup>th</sup>-17<sup>th</sup>, 2018***

**Dario Foppoli  
Emanuele Moretta  
Foppoli Moretta e Associati  
Tirano (SO) - ITALY  
[posta@foppolimoretta.it](mailto:posta@foppolimoretta.it)  
[www.foppolimoretta.it](http://www.foppolimoretta.it)**

**THEME 1 - Extending the Life of Bridges: Investigation & Repair**

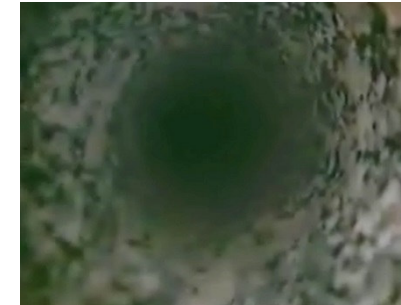
depth 30cm

Coring and video-inspection of the foundation of the left pier

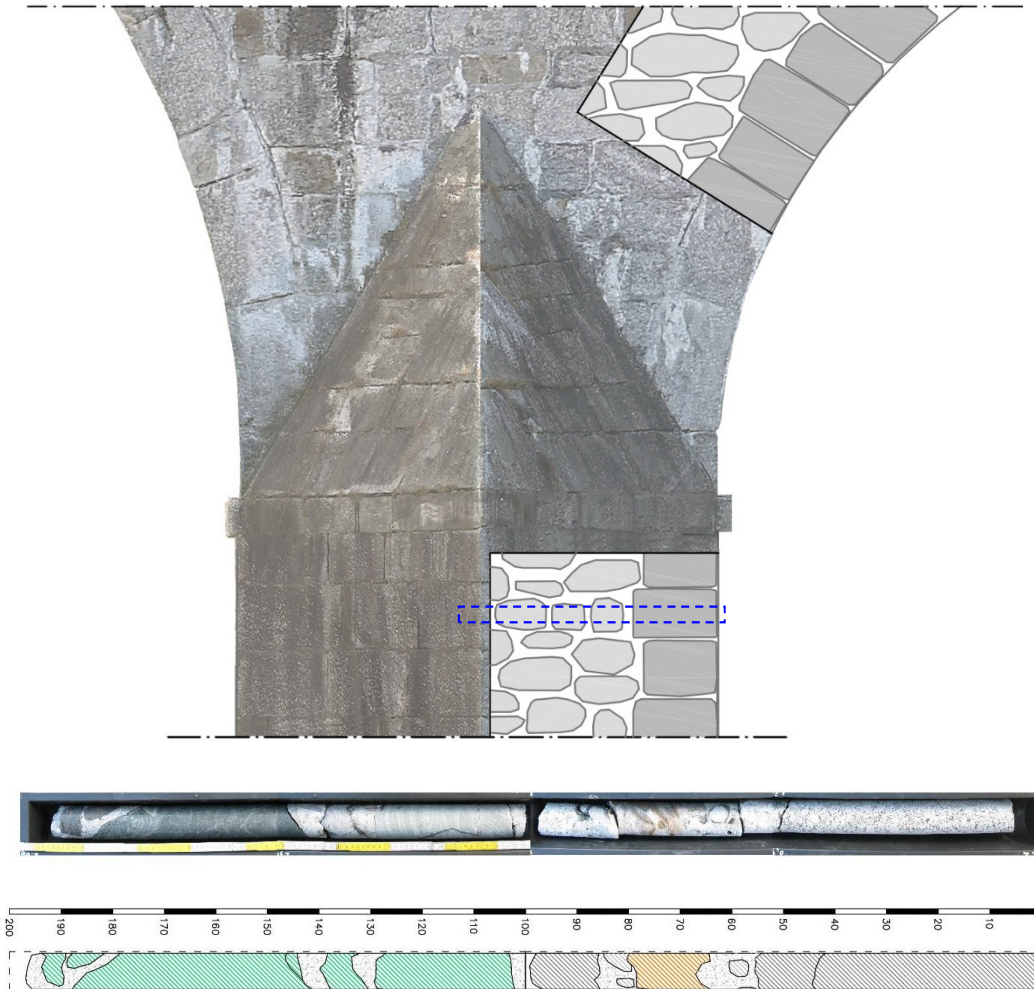
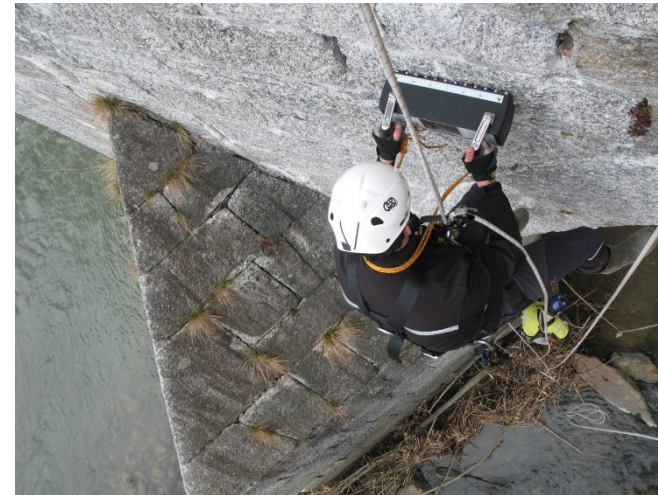
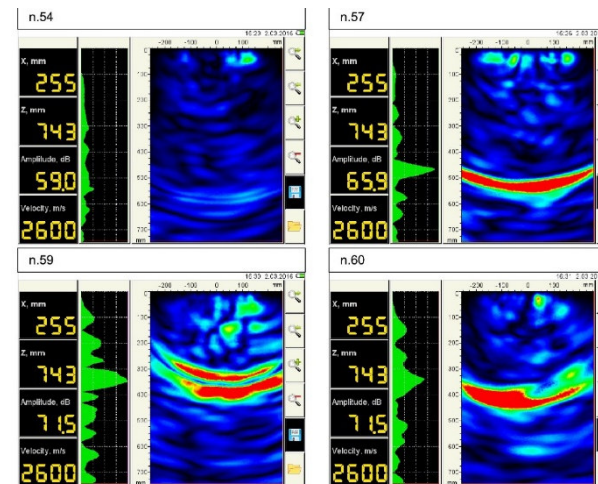
Coring and video-inspection of the masonry of the right pier  
Tomographic tests performed with positioning techniques by ropes

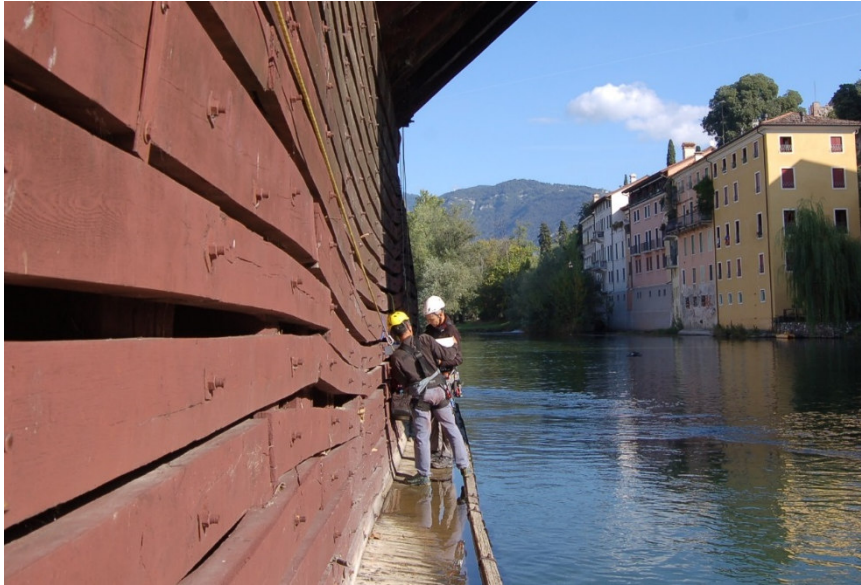
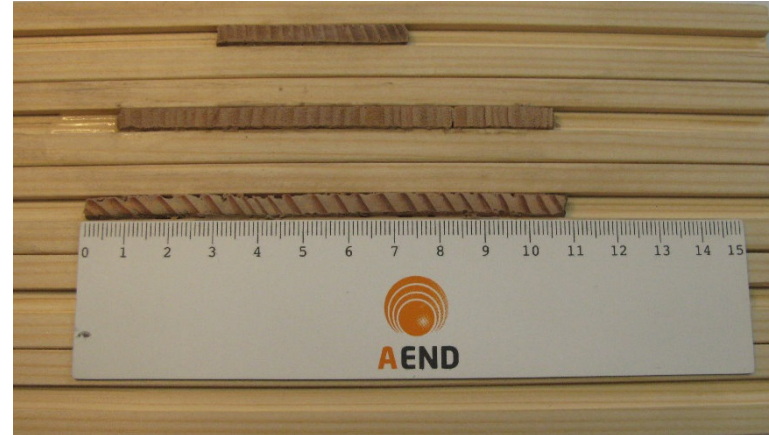
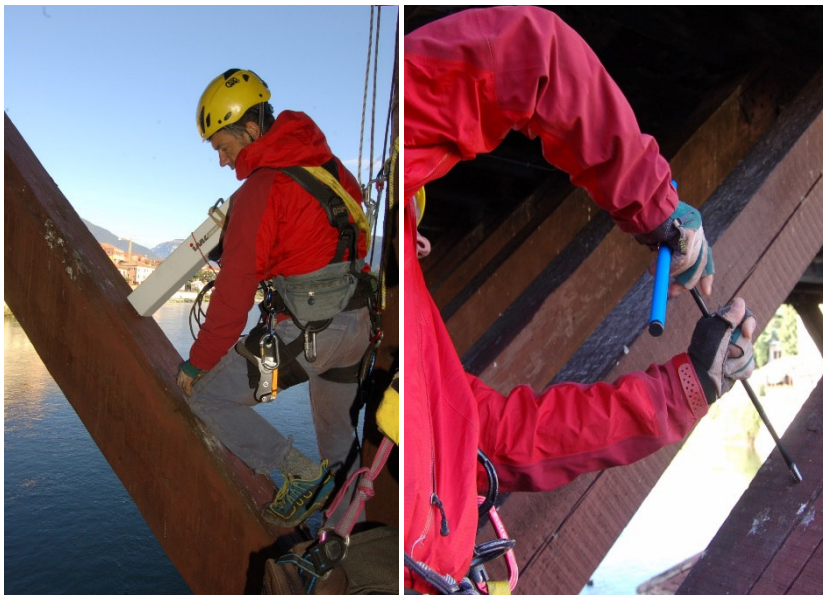
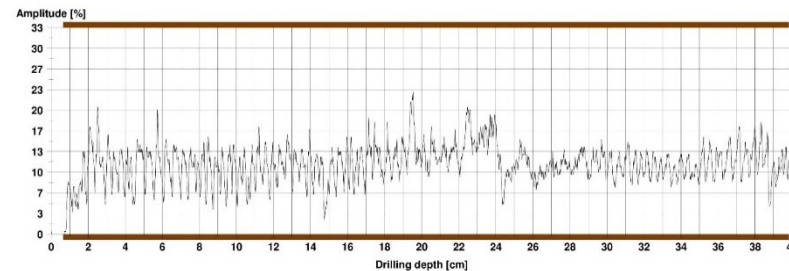
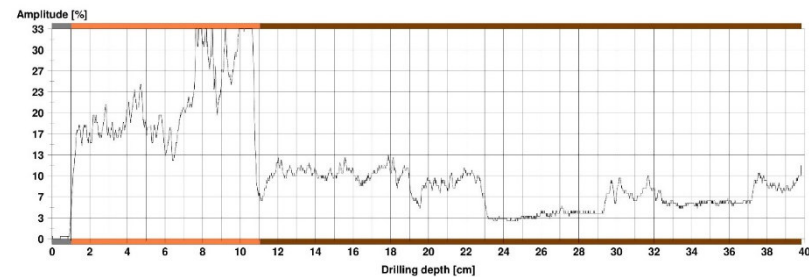
Micro drilling tests (with Resistograph)  
on the wooden trusses and wood  
sampling by means of Pressler auger

Pole of the spurs reinforced with two lateral planks, connected with metal rods (1N)

Pole under the deck reinforced with steel elements, connected with threaded metal rods (1D)

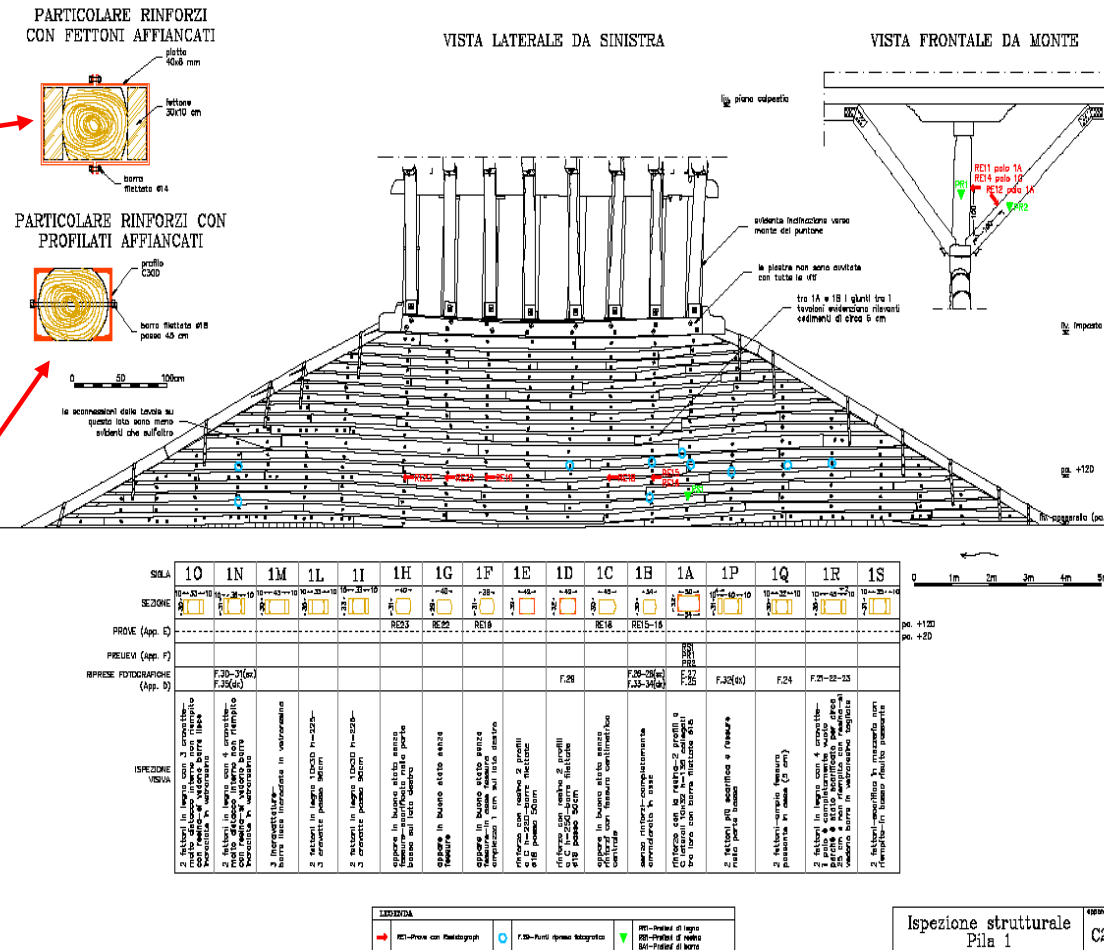
Information from inspection represented on the face of the piers

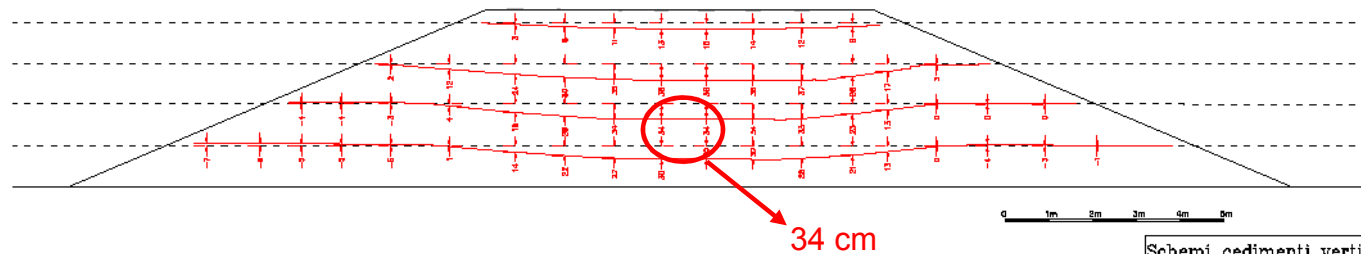
VISTA LATERALE DA SINISTRA-PILA 2

Schemi cedimenti verticali  
Pila1-Pila2

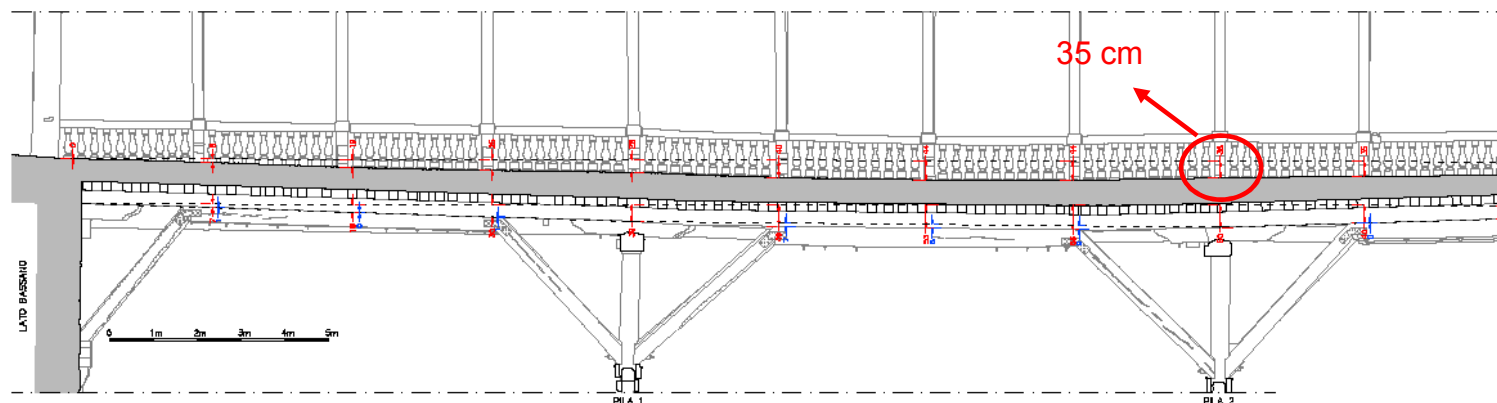
SEZIONE LONGITUDINALE

Settlements within pier measured on the basis of planks deformations  
Settlement of the piles measured on the basis of deck deformations

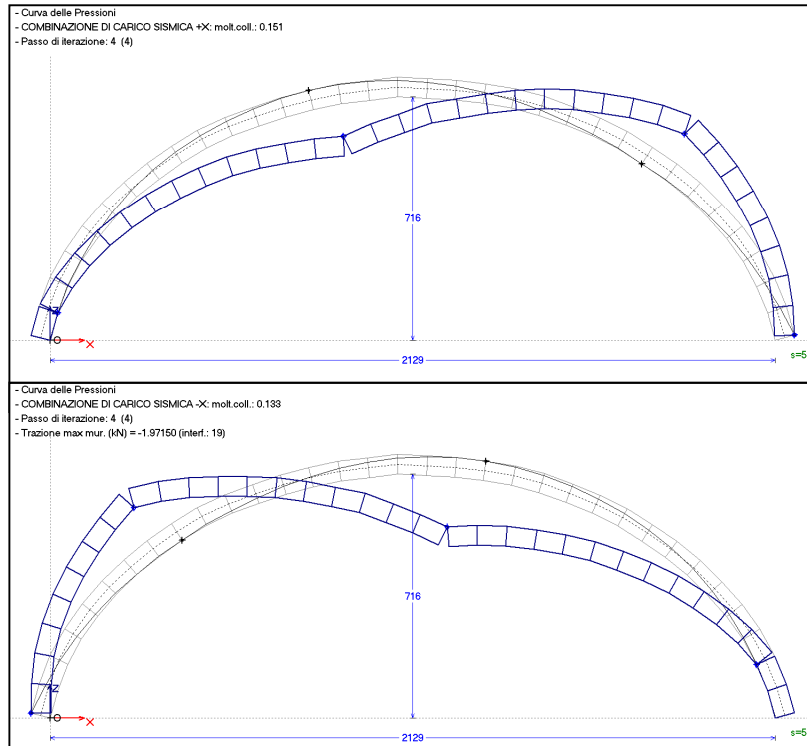
## Kinematic analysis, Seismic risk indicators

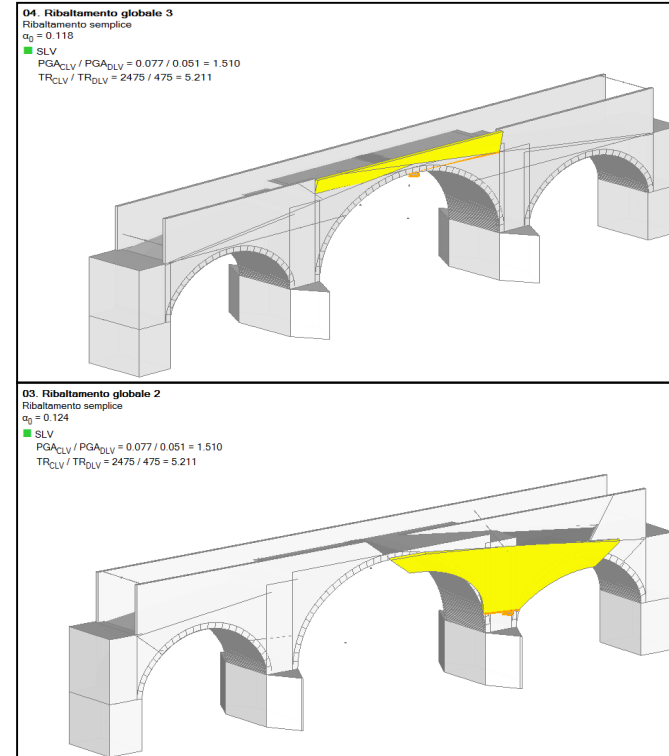
## Macro-element analysis, Seismic risk indicators

- in termini di PGA:  $(PGA_{CLV} / PGA_{DLV}) = 0.077 \text{ g} / 0.051 \text{ g} = 1.510 \geq 1$
- in termini di TR :  $(TR_{CLV} / TR_{DLV}) = 2475 \text{ anni} / 475 \text{ anni} = 5.210 \geq 1$   
 $(TR_{CLV} / TR_{DLV})^{0.41} = (2475 \text{ anni} / 475 \text{ anni})^{0.41} = 1.968 \geq 1$
- in termini di  $V_a$ :  $>2475 \text{ anni}$

Seismic assessment of the bridge qualified as pedestrian walkway (3<sup>rd</sup> category)
