# **The Knowledge of a Three Arched Stone Bridge in the Alpine Region Based on the Comparison between Historical Analysis and Diagnostic Data**

Dario Foppoli

Foppoli Moretta e Associati - TIRANO (SO)

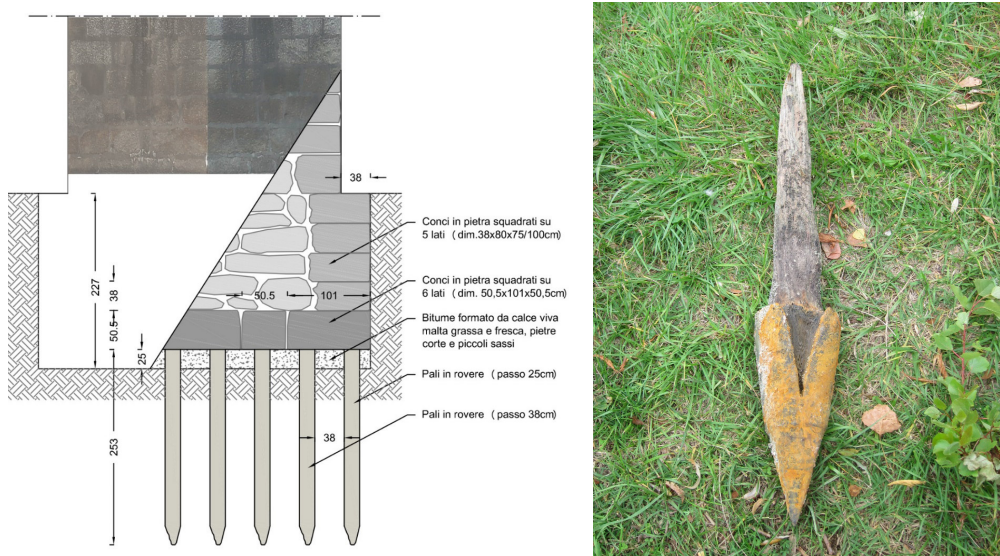
*Fig. 3 foundation construction in compliance with the “Chapters”;  
nailed poles recovered at Bassano bridge site (XVI-XVIII century)*

On the contrary, from the documents, the rebuilding of the left column foundation followed the guidelines. To confirm this, corings were carried out (fig 3). In agreement with the diagnostic results, masonry is haphazard and not following guidelines: mortar of bad quality with stones and lumps of brick was used. Abundant water leaks from the bore hole showing the great amount of holes that allow water filtration inside the structure. While reaching the maximum depth possible (as indicated in the “Chapters”) through coring, it wasn’t possible to recover cores from the foundation stones; conversely wooden fragments from the poles were recovered proving their use in foundation reinforcement.

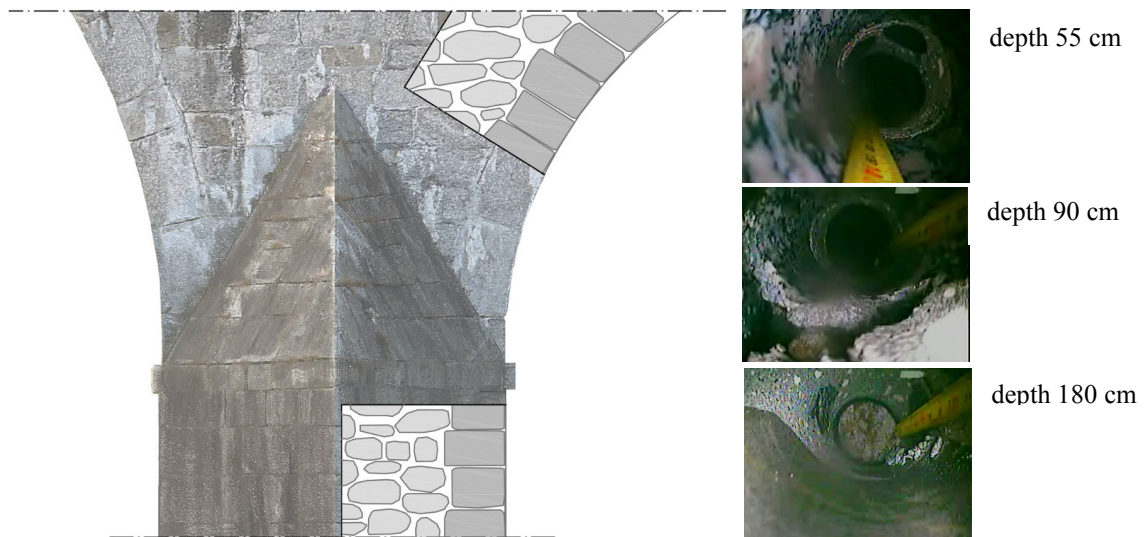
*Fig. 4 a pile as shown in the Chapters; images coming from coring holes inspected with endoscopic video camera*

The right pile, under investigation, shows the use of irregular stones but of 63 cm thickness, good mortar condition and infilling made with stones of varying lithology and size 20-40 cm. Coring allowed for direct inspection the half thickness of a pile, as the other side would be symmetrical. Results confirm the “Chapters” prescription of uniform layer construction. The abutment on the left side shows irregular blocks from 45 to 60 cm used on the external face, compact mortar and yet stones sized 20-40 cm used for the infilling.

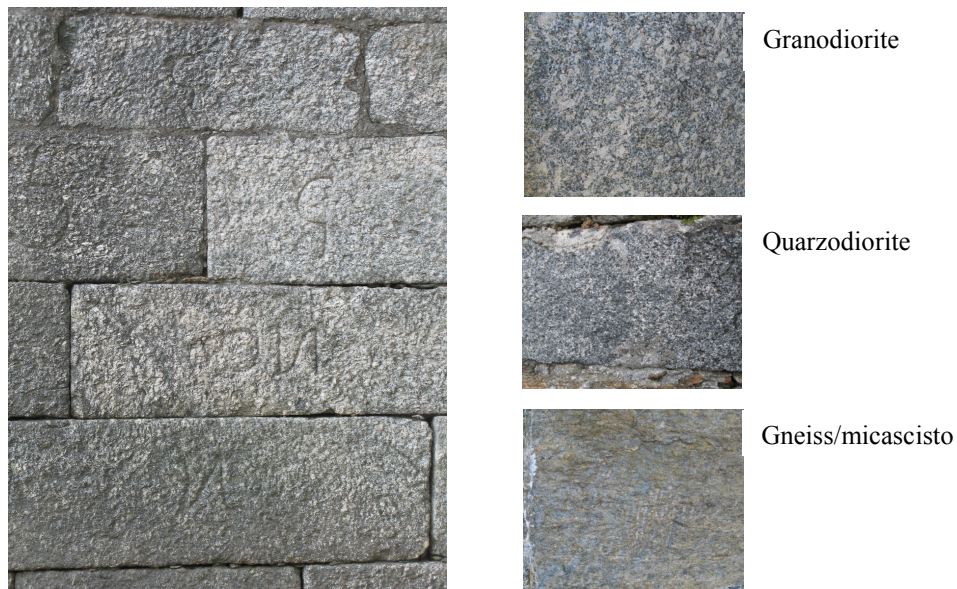
*Fig. 6 signs left by the stonecutters during construction*

From close up, many signs left by the stonecutters during construction can be seen (Fig. 6). The symbols, probably marks made by stonecutters, are grouped together principally in 3 groups, Z, Ç and NO. There is no order to the symbols suggesting no particular

assembly hierarchy. Stones were laid with great care while external mortar, due to the limited thickness of the joints, is eroded or absent, while the erosion not reach serious depth inside the structure.

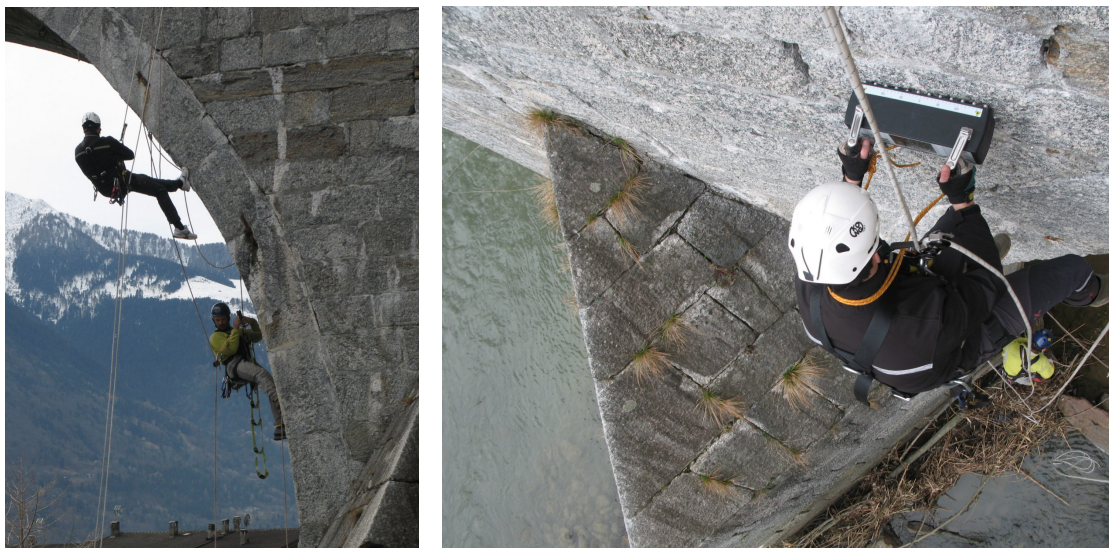
Rope inspection of both sides of the bridge gives a detailed analysis of cracks and deformations as well as the general state of bridge conservation. Voussoirs and external parameters maintain a good standard of masonry. The arch and buttresses show continuity with original planning; higher sections, however, are showing signals of sliding.

The archway intrados show significant signs of discontinuity between voussoirs and the vault. On the right arch this has led to a lowering of the vault compared to the front arch. Concretions are present in the intrados showing the gradual washing away of mortar in the masonry. The water breaks are positioned above lateral masonry and made of pyramid shaped blocks; they are not connected to the masonry behind and are now significantly detached from their original position. The apex and the blocks below show the absence of mortar in the joints; vegetation can be seen on the left side of the bridge between the joints.

Pile masonry appears solid; however at the base of the right pier, where heavy water flows occur, mortar has been eroded and washed away. In this area one block is so badly connected that it is now held in place only by iron bars. Joints at the base of the left column are in a bad shape, grouted with cementitious mortar. Furthermore on the upstream masonry of the left arch there is a visible crack developing along the mortar joint line (it is however the only relevant crack for the whole bridge).

*Fig. 7 inspection and ultrasonic measurements performed with positioning techniques by ropes*
