**CODE 535****INSPECTION, DIAGNOSTIC ANALYSIS AND SEISMIC IMPROVEMENT  
OF BUILDINGS DAMAGED BY SEISMIC EVENTS:  
S. MARIA ASSUNTA CHURCH AT FABBRICO (ITALY)****Armanasco, Alessandro<sup>1</sup>; Foppoli, Dario<sup>2</sup>**

Foppoli Moretta e Associati Consulting Engineers, Tirano (SO) ITALY

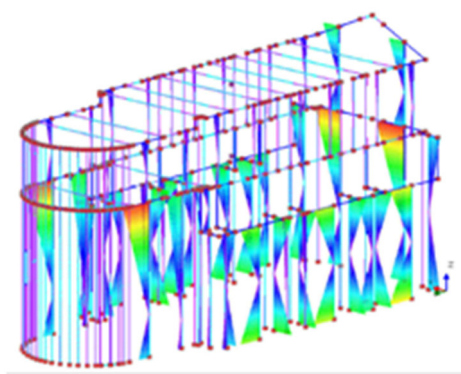
Figure 4: LV3 analysis, shear assessment

The analysis was carried out by means of three-dimensional numerical modelling (Fig.4); the seismic verification was carried out by linear static analysis. The intrinsic non-linearity effects in the structural behaviour of the masonry have been taken into account by identifying the crack pattern and by modelling the consequent discontinuities verified by recursive comparison with the calculated tensile stresses. The analysis was integrated by the LV2 analysis of local collapse mechanisms (Fig. 5).

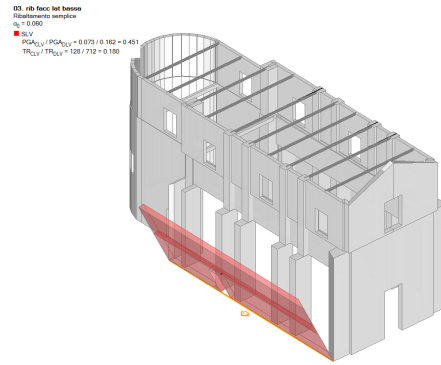
Figure 5: LV2 analysis, collapse mechanisms

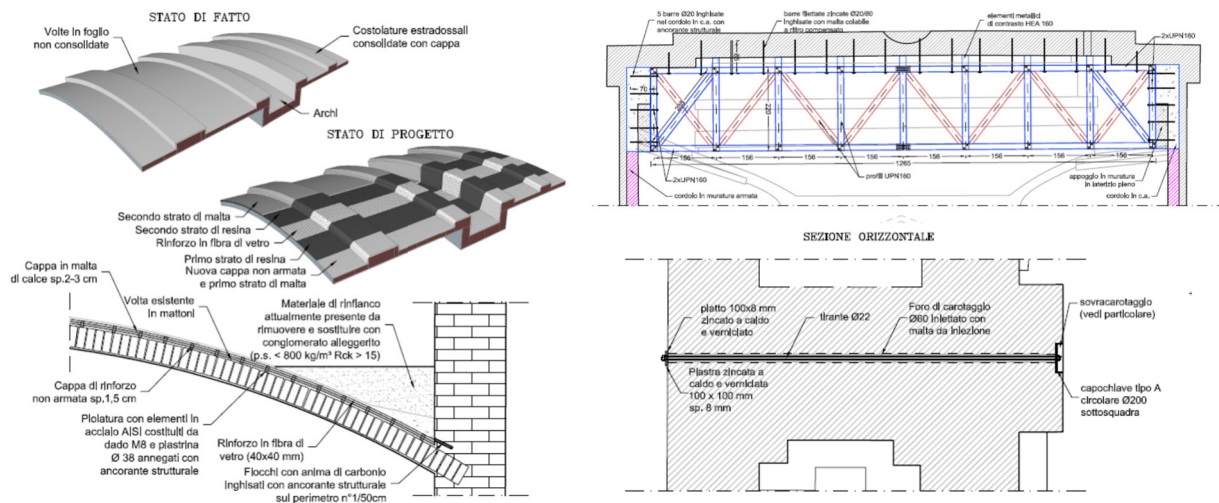
The vault of the nave is shaped like a “sheet” barrel vault (about 8 cm thickness), with lunettes corresponding to the side wall windows, stiffened at the extrados through ribs made with bricks placed on the side. The intrados arches protrude and divide the spans of the hall and present tie-rods placed at the springs. At the extrados of the ribs and of the arches, a thin reinforced concrete coating was placed (without steel connectors) during a previous intervention of consolidation; in addition an R.C. beam was constructed at the key of the vault, thereby incorporating the chords of the trusses, aiming to suspend the vault through metal tie-rods. This system is of dubious effectiveness, as evidenced by the significant crack pattern caused by the recent earthquake, that was not counteracted by the described reinforcements. The main damage occurred in correspondence with the first and the last span, resulting in shear cracks arranged at 45 °.

Figure 6: Interventions on the main vault Figure 7: Stiffness of the front façade

The earthquake also underlined the possibility of overturning the front façade, as evidenced by the wide crack between the vault of the hall and the internal façade. This proved also the ineffectiveness of the system of metal tie-rods connected to the R.C. beam. The re-tightening of the tie-rods of the side walls previously described is instead effective also in counteracting the façade's tilting. To inhibit such mechanisms, a metal truss was inserted at the extrados of the vault of the nave so connecting the front façade in a distributed way (Fig. 7) and spreading the horizontal seismic loads to the reinforced support curb. The vertical cracks in the façade were finally repaired by means of localized interventions (*"cuci-scuci"*).

Therefore, the elimination of the R.C. beam with its tie-rods was drawn up and its replacement with a reticular metal beam to counteract the tilting of the front façade implemented. Subsequently, the intervention has seen the application of a covering of Fibre-Reinforced Inorganic Matrix material

(FRCM) reinforced with fiberglass fabric (fig. 6) and connected to the vault with metal connectors glued to the extrados of the vault (drilling connecting holes in the bricks is impossible because of their limited thickness). For the execution of the foreseen operations, it was indispensable to carry out the preliminary shoring of the vault by a scaffolding on the top of which a worktop was built on which metal adjustable props were placed to support a system of wooden ribs.

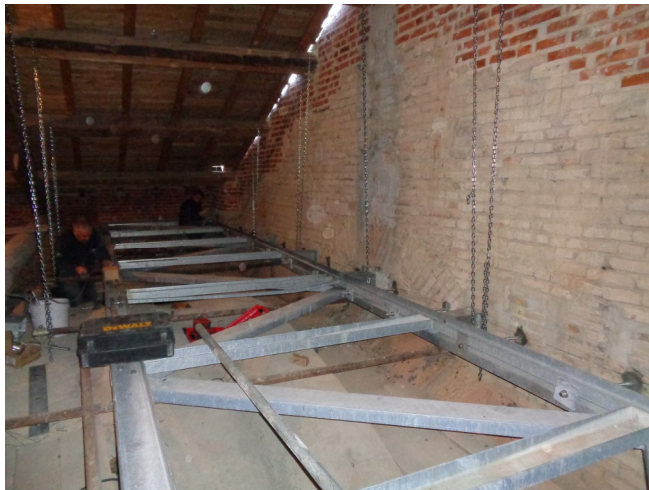
The following building site also allowed us to observe the building in a close and systematic way, so confirming the results provided by the diagnostic activity. This fact was fundamental for the definition of the executive details of the intervention, which could be designed and implemented with great precision and operative attention. Indeed, the careful diagnosis and design phases prevented making any major adjustments from the planning to the site (Fig. 8 vs. Fig. 7).

Figure 8: horizontal metal truss of the front façade Figure 9: Pull-out test on the connectors with the façade

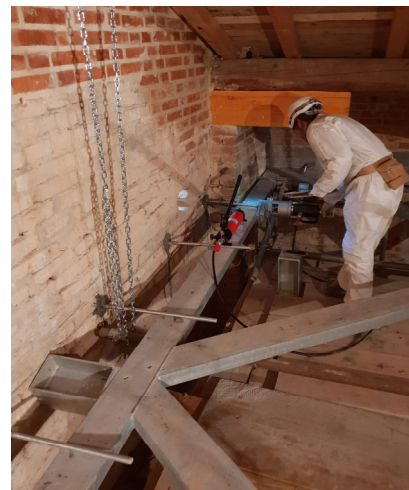
In the works supervision phase, additional on-site tests were also prescribed to prove the effectiveness of the designed reinforcement elements, such as pull-out tests to assess the tensile strength of the connectors between the metal truss and the façade (Fig. 9).
