## Inspections and NDT for the Characterization of Historical Buildings after Seismic Events: Emilia Earthquake

D. Foppoli

Foppoli Moretta e Associati, Tirano (SO), Italy

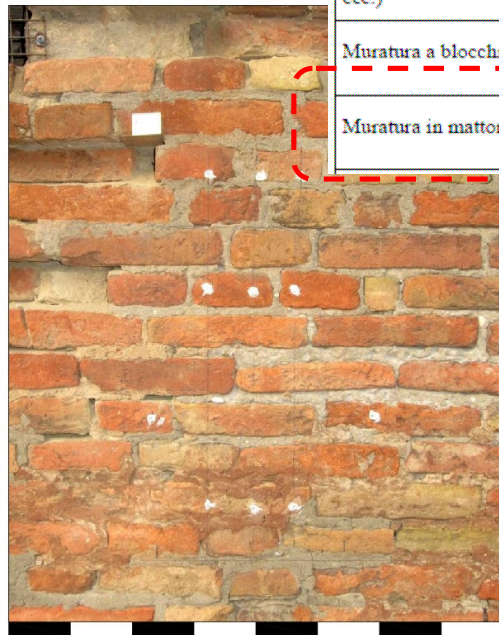
L'AQUILA

disordered  
masonry  
made with  
rubble stone

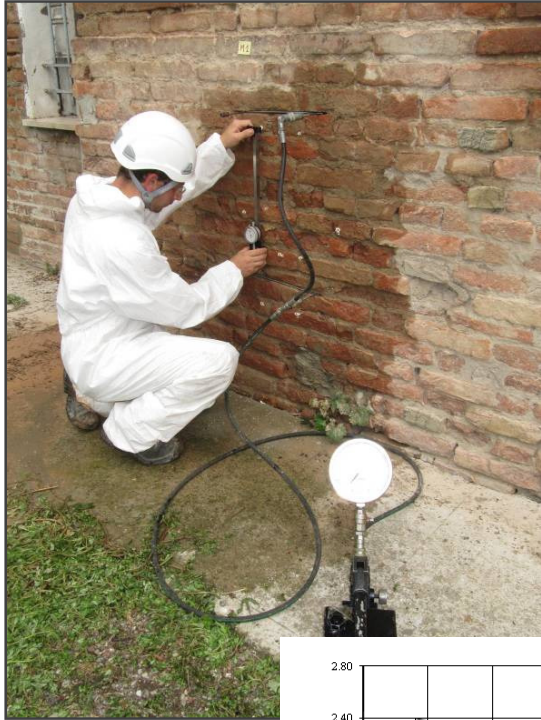
### 3. Test methods – flat jacks

- The compressive stress within masonry was estimated using flat jack measurements (ASTM C 1196-09) -coefficient of variation as great as 20%.
- The deformability properties were measured with two flat jacks (ASTM C 1197-09) - variations between tests as great as 24%.
- This last test also allows to measure the maximum compressive strength - overestimation up to 15%.

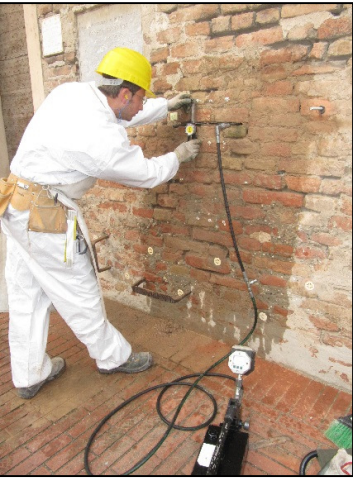
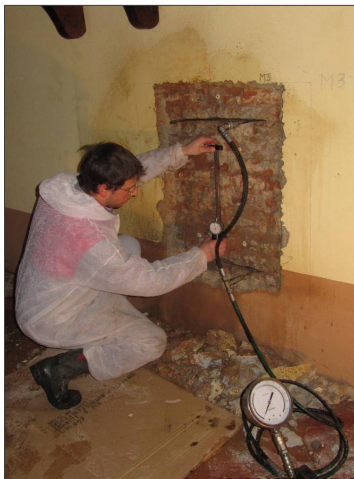
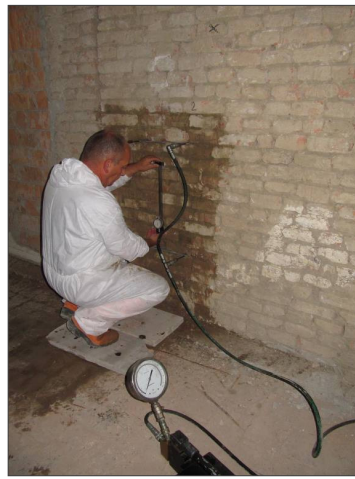
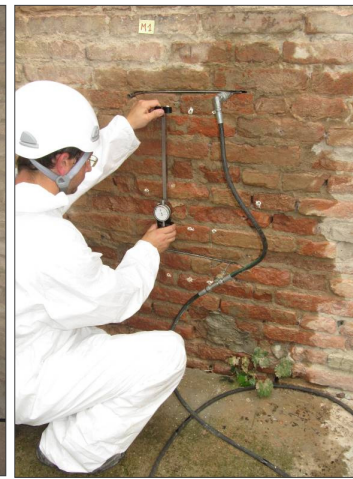
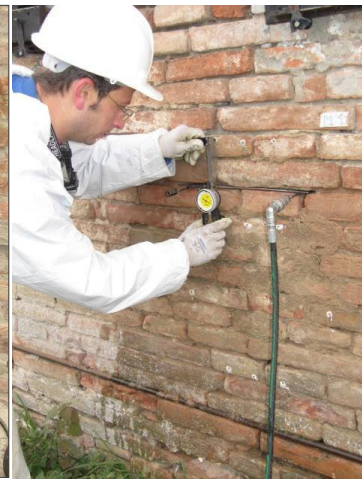
PROVA CON MARTINETTI PIATTI  
DETERMINAZIONE DELLE CARATTERISTICHE DI DEFORMABILITA'  
DIAGRAMMA SOLLECITAZIONE-DEFORMAZIONE  
PROVA M1B

PROVA CON MARTINETTI PIATTI  
DETERMINAZIONE DELLE CARATTERISTICHE DI DEFORMABILITA'  
DIAGRAMMA SOLLECITAZIONE-DEFORMAZIONE  
PROVA M2B

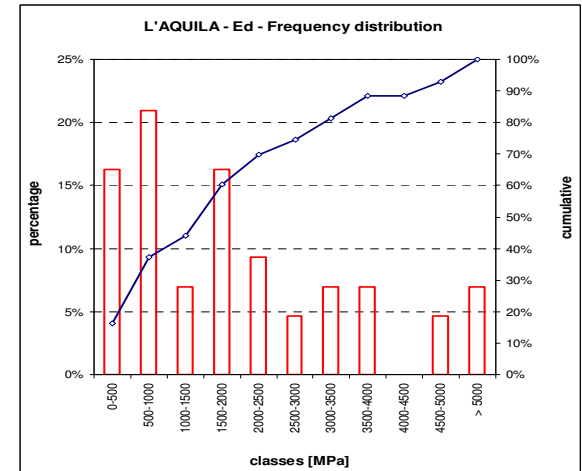
## L'AQUILA

$$E_{d\text{ av}} = 2248 \text{ [MPa]}$$

$$E_d \text{ vs } f_m \\ R^2 = 0,45$$

- The comparison of the data related to L'Aquila stonework masonry and those related to Emilia solid brick masonry is significant.
- **The Italian code** adequately captures the mechanical characteristics of the rubble stonework masonry, but **does not appear sufficiently accurate in defining the mechanical properties of solid brick masonry**.
- The current standard divides stonework masonry in many typologies, depending on the texture, while ranks the brick masonry in a single typology, presumably because, there are not evident differences in the texture of these walls.
- **The mechanical properties of brick masonry are strongly influenced by the quality of the mortar and by the joint thickness**: this variability should be taken into account by the seismic code to obtain a classification closer to the real characteristics of the masonry.

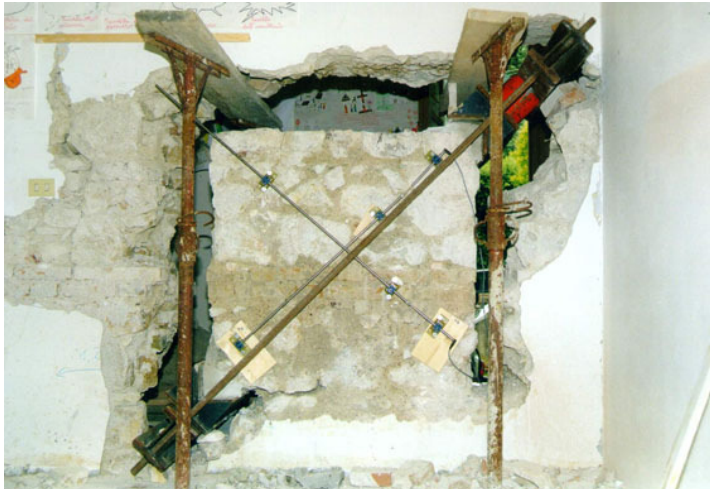
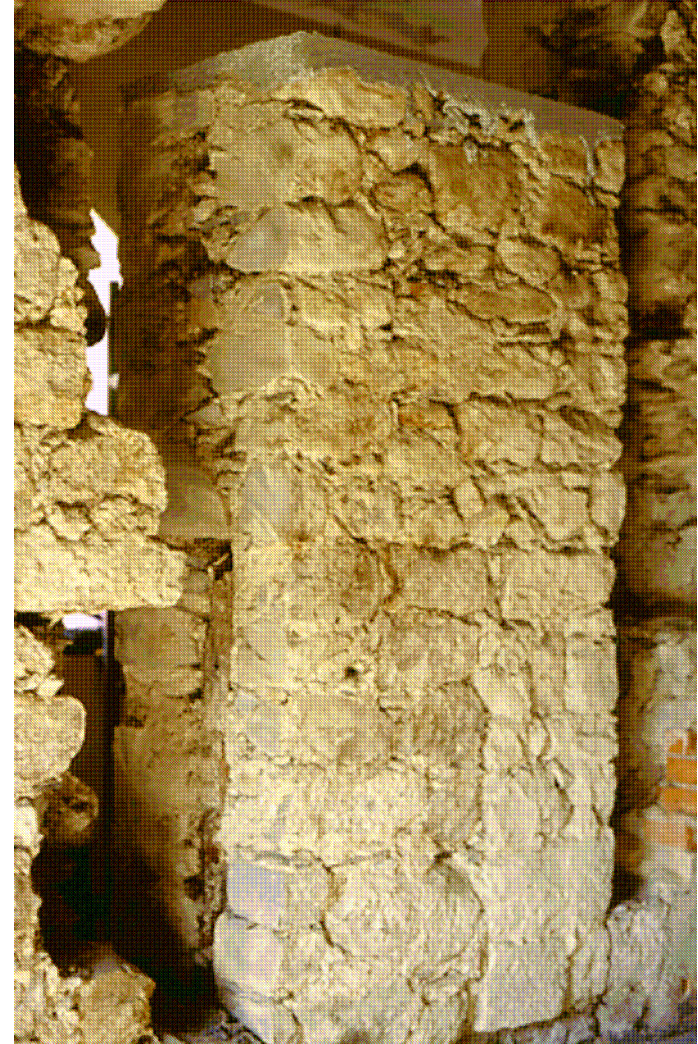
# 5. Standard Shear Test

- The in situ tests currently applied can be classified according to three methodologies:
  1. diagonal compression test (ASTM E519-81)
  2. shear compression test
  3. on site shove tests (RILEM TC 127 MS B.4)
- These are Highly Destructive Tests, so as to be unsuitable in use for existing buildings

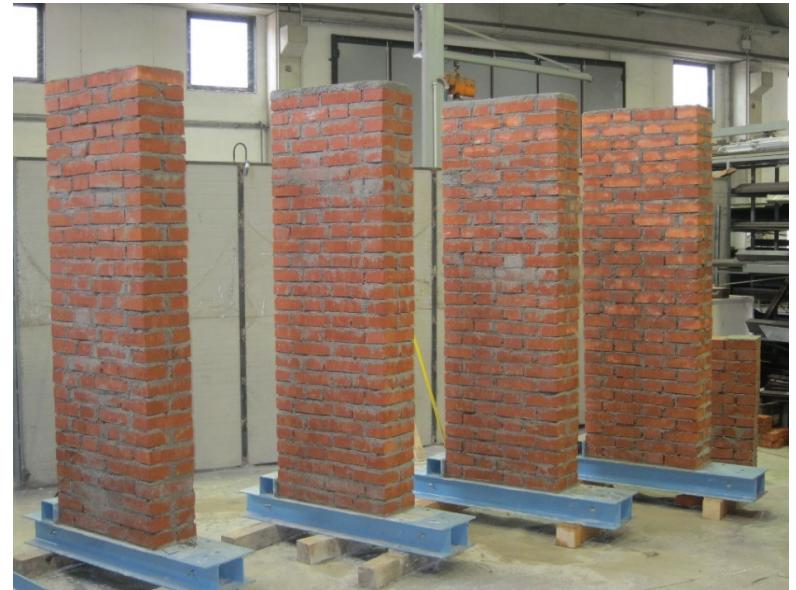
# 5. Flat Jack-Shear Compression Test – Laboratory Calibration

- The calibration of the **FJ-SCT** technique was performed in **FMeA** laboratory on real scale brick masonry panels.
- The panels were built with new bricks with low nominal resistance, mortar with poor quantity of lime and mortar joints of considerable thickness in order to obtain walls with poor mechanical properties, similar the buildings in the Italian Pianura Padana (Emilia region)  $1,0 \text{ MPa} < f_m < 2,0 \text{ MPa}$ .
- Bricks, mortar and sand were sampled during the construction and they were analysed with ultrasonic, compression and indirect traction tests.

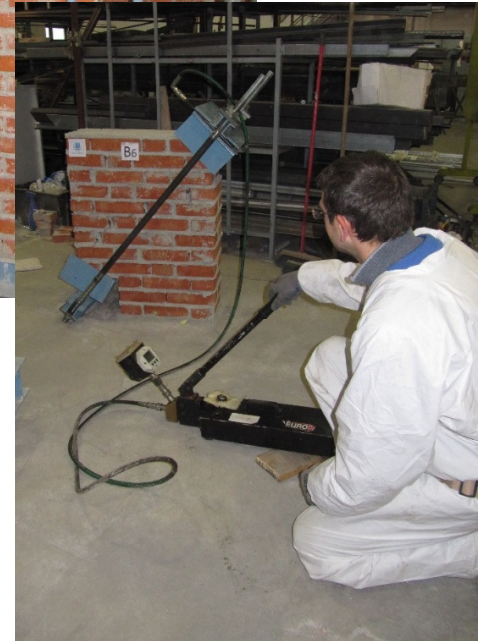
CONTRAST  
FRAME USED  
FOR THE  
CALIBRATION
