## MECHANICAL CHARACTERIZATION OF TRADITIONAL MASONRY IN AN HOMOGENEOUS TERRITORY: VALTELLINA

**Keywords :** Valtellina, masonry, drystones, stones, lime mortar, Non Destructive Testing.

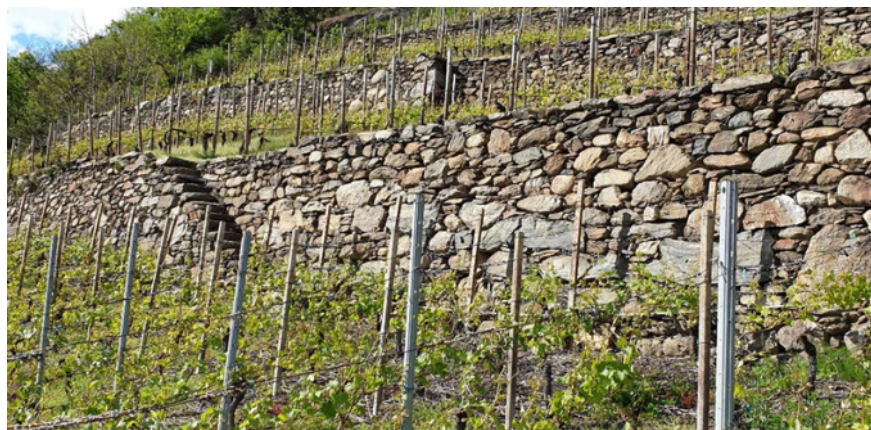
Figure 2: Typical facing of a drystone wall of the Valtellina terraces

In the territorial context of this study the characteristics of drystone masonry (*Fig. 2*) have strongly permeated even the techniques of stone and mortar ones: that's why useful information for the ordinary buildings can also come from the study of the construction techniques of the drystone masonry. On the basis of the technical literature the stability of a drystone wall is strongly related to the experience and to the skill of the mason, who has to respect six specific "rules of art" [5]: proper setting of the foundation (generally with low depth), vertical offset of the joints to obtain the optimal distribution of the weights; horizontality of the stone courses;

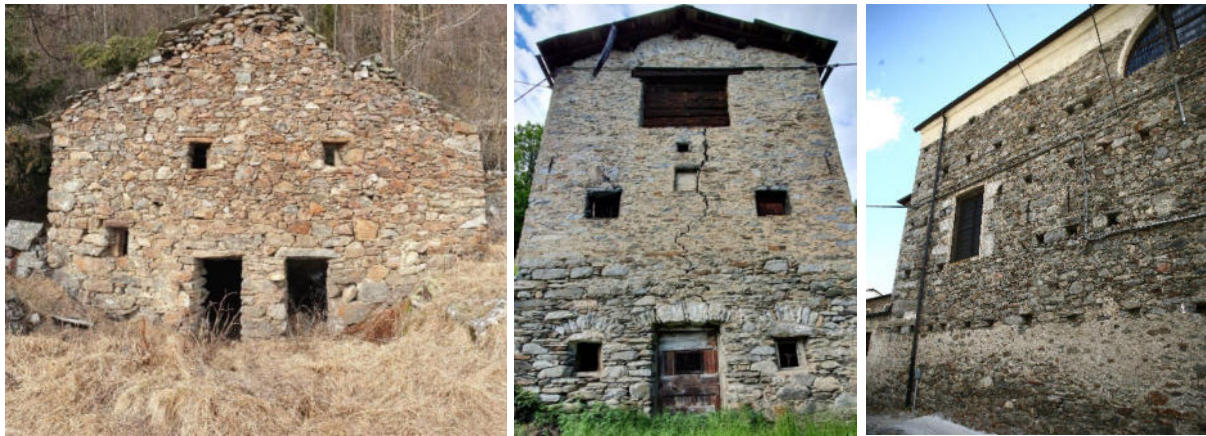
**Figure 3: Similarities among the drystone rural construction (left), stone and mortar rural construction (middle) and stone and mortar wall of the church of S. Ignazio in Ponte in Valtellina (right)**

The main part of Valtellina buildings, even those that can be classified as cultural heritage (churches, palaces and rural nuclei) are characterized by a lithological variety and by the use of construction techniques almost indistinguishable from the drystone walls, although generally encompassing the use of mortar (*Fig. 3*).
