# Diagnostic Campaign Aimed at Assessing the Seismic Vulnerability of Existing Buildings Applied to Strategic Buildings in Trentino Alto Adige (Northern Italy)

The paper describes the diagnostic activities carried out, on behalf of the Italian State Property Office, on some buildings located in Predazzo (Trentino Alto Adige Region - Northern Italy) built along the 20<sup>th</sup> c., which were originally intended as barracks and currently hosts the Alpine School of the Financial Police. These are very common situations in Italy: historic buildings, built with different construction techniques (both masonry and Reinforced Concrete and mixed techniques) and subject to multiple functional transformations over time.

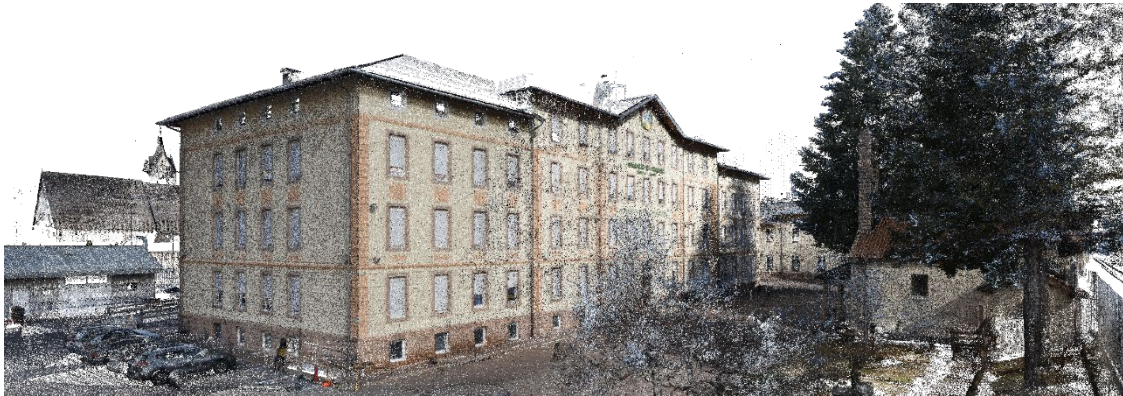
**Figure 2:** View of the point clouds from the survey of *Macchi* barracks

The acquired data are then post-processed through software that allows them to be verified for correctness, corrected for eventual problems, and merged in such a way as to create the digital model of the building (Fig. 2). The final product consists of a single geo-referenced point cloud that collects all the information acquired during the survey.

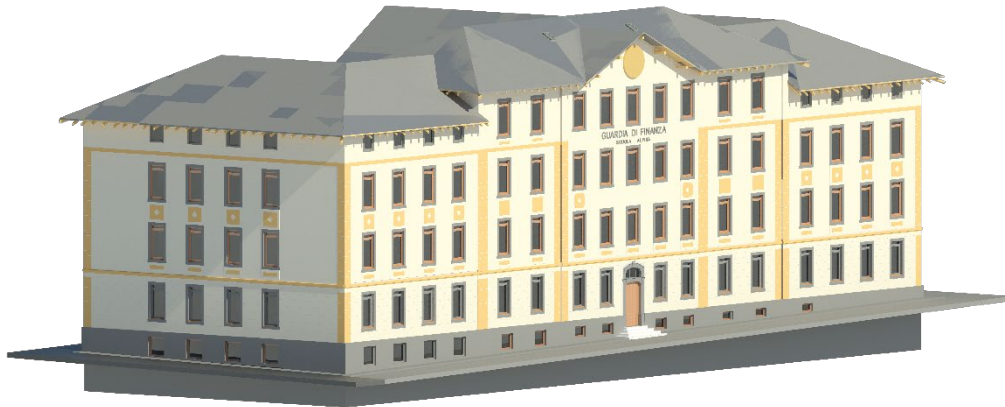
**Figure 6:** View of BIM model of *Macchi* barracks

point cloud, which allows a detailed reconstruction of the architectural shape of the buildings (Fig. 7). The model was developed up to the appropriate Level of Development (LOD = 300) [8].

The model was then integrated with the information provided by the diagnostic campaign. For example, the entire crack pattern detected was reproduced in the BIM model with the aid of systems of element adapted to the specific need, starting from families pre-existing in the software. The elements inserted in the real position of the crack simulation, its trend and the groups created by the union of the different elements have been associated with parameters that describe the peculiarities of the crack (coding, opening, severity, urgency, ..).
