## From Palladio to Reinforced Concrete: NDT Applied to the Old and the New Bridge of Bassano del Grappa

Dario FOPPOLI

Foppoli Moretta e Associati s.r.l., v. Damiani, 2, 23037 Tirano (SO) ITALY

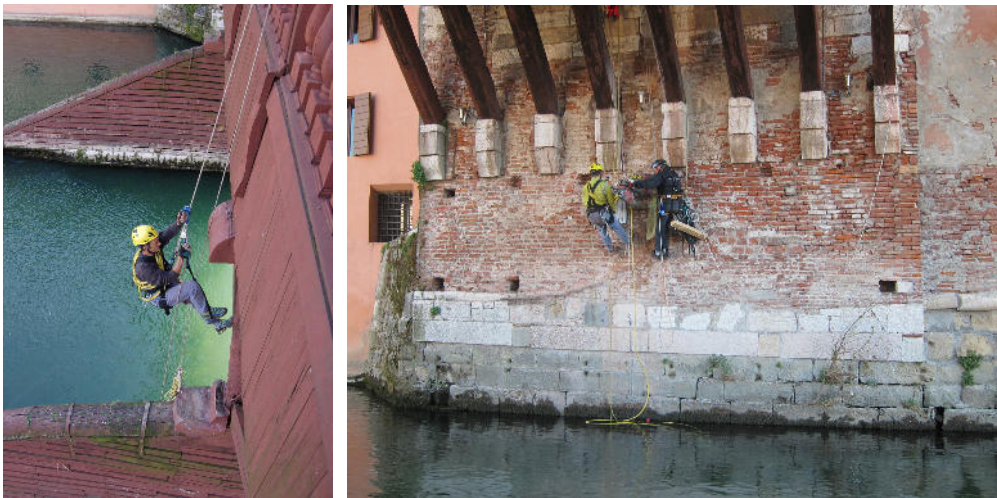
The other key element in the structural assessment of the bridge was its abutments which on the surface appear to be made partly of bricks and partly of stone blocks. Their geometrical characteristics and composition and the masonry stress state and mechanical characteristics were assessed. Core samplings, surveyed with additional video-inspections and single and double flat jack tests were performed. In this case too, rope access and positioning techniques proved to be the only way to operate (Fig. 4).

Figure 4: Rope access and positioning for inspections and tests
