CHARACTERISATION OF DIFFERENT MATERIALS AND CONSTRUCTIVE TECHNIQUES OF HERITAGE BRIDGES IN THE NORTHERN ITALY

Dario Foppoli
Foppoli Moretta e Associati
via Albonico, 17
23037 TIRANO (SO)
ITALY

KEY-WORDS: Masonry bridge, wooden trussed bridge, heritage bridges, investigation, case study

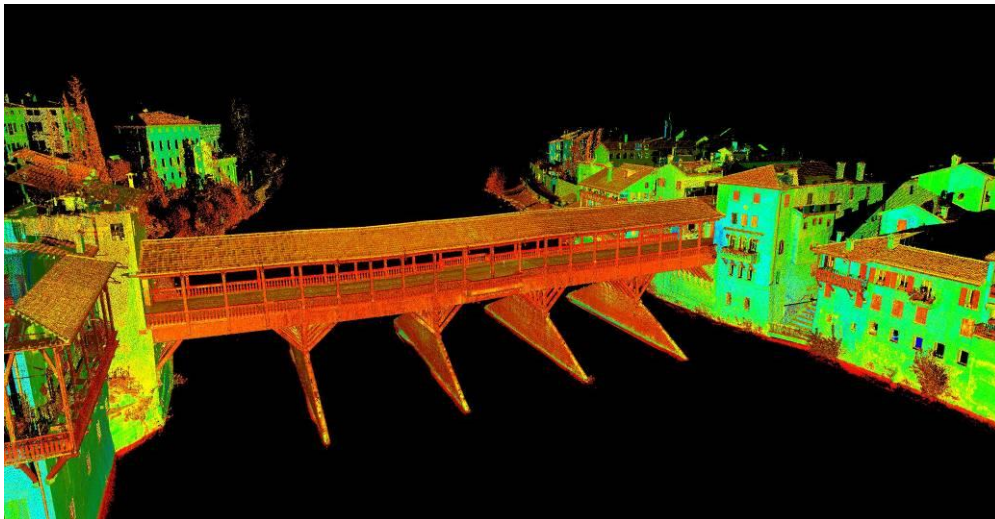
The old bridge of Bassano del Grappa (in Italy) is placed along the Brenta River that flows through the city. The structure has an overall length of 65 m and a width of 8.5 m; it is composed of five spans resting on two masonry abutments and on four piers sunk in the riverbed (Fig. 1). The piers are made of 8 poles of equal length to support the deck and six additional poles in decreasing lengths arranged both upstream and downstream to form the spurs. The deck is supported by eight beams arranged longitudinally to the bridge; the whole structure is made with wooden trusses

Fig. 1: shot of points-cloud carried from laser-scanner survey of the old bridge of Bassano

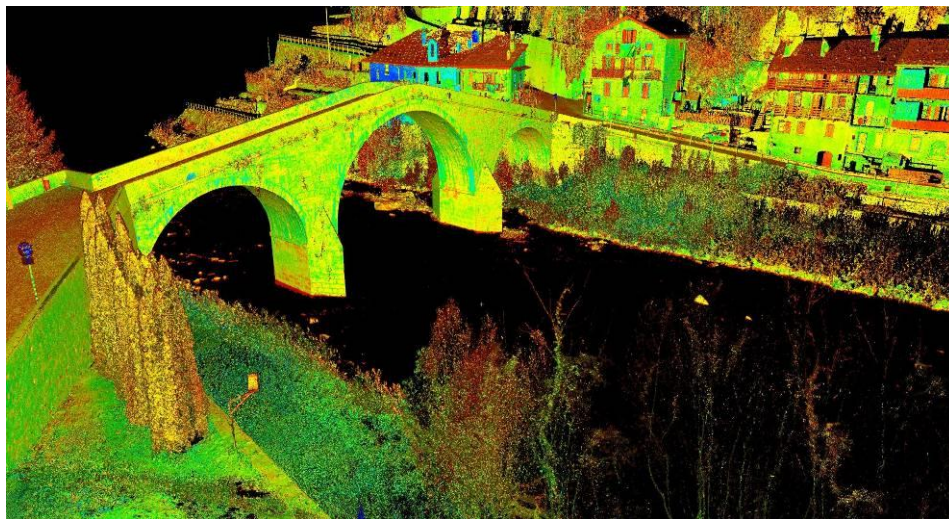
The Ganda bridge is placed upon the Adda River, not far from its entering in the Como Lake; it has an overall length of 57 m and a width of 6,20 m and is composed of 3 arches entirely made with squared stone masonry (Fig. 4).

Fig. 4 shot of points-cloud carried from laser scanner survey of Ganda Bridge

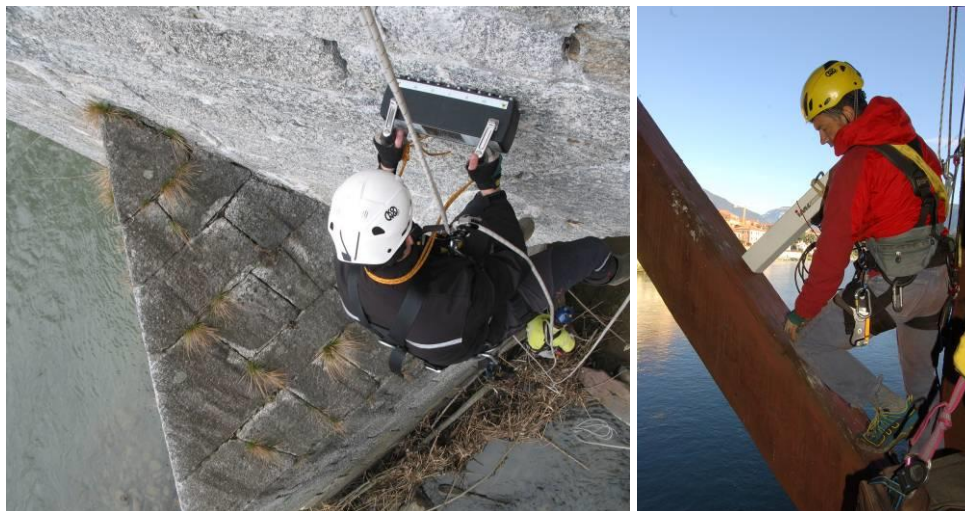
Where signs of deterioration such as cracks, fissures, torsions, wood rot and holes of xylophages insects were found, the visual investigation, performed in compliance with UNI 11119:2004, was integrated through the use of manual tools (awl and hammer). In this way, it was possible to outline the area to be subjected to a more accurate instrumental analysis, carried out by Resistograph (Piazza & Del Senno, 2001), in order to locate and quantify regions of internal decay on timber elements (Fig. 5).

Fig. 5 ultrasonic tomography on masonry and execution of measurement of drill resistance on wood both performed by ropes access techniques
