# Characterisation of Different Materials and Constructive Techniques of Heritage Bridges in Northern Italy

***Structural Faults + Repair-2018 &  
European Bridge Conference-2018  
Edinburgh, May 15<sup>th</sup>-17<sup>th</sup>, 2018***

**Dario Foppoli  
Emanuele Moretta  
Foppoli Moretta e Associati  
Tirano (SO) - ITALY  
[posta@foppolimoretta.it](mailto:posta@foppolimoretta.it)  
[www.foppolimoretta.it](http://www.foppolimoretta.it)**

**THEME 1 - Extending the Life of Bridges: Investigation & Repair**

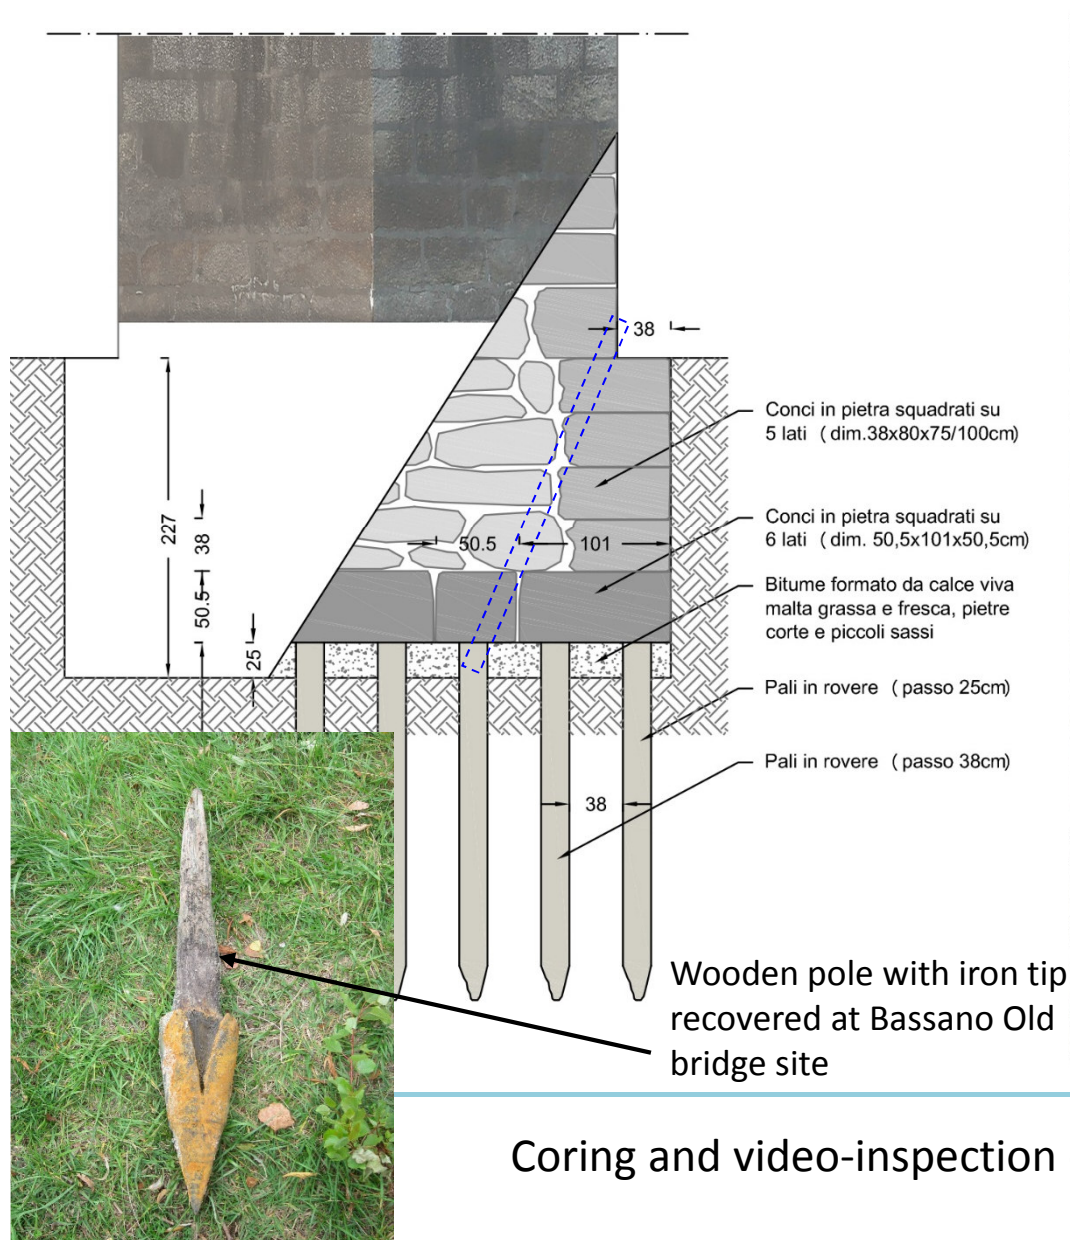
Coring and video-inspection of the foundation of the left pier

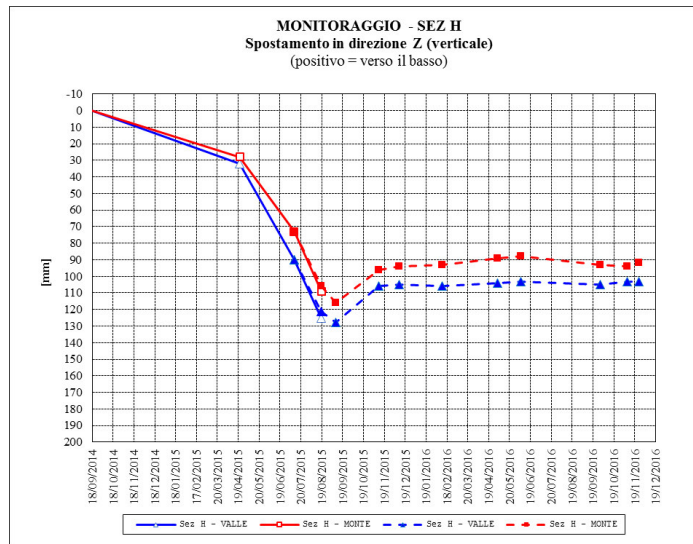
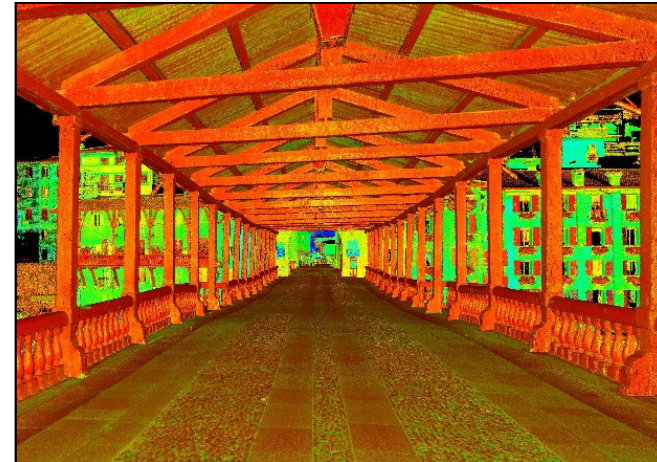
Laser scanner measurement

Monitoring was started by scans thought Scanner HDS 7000 Leica Geosystems, and continued by topographic targets surveyed thought Leica TCRA 1201 “total station”
