**CODE 535****INSPECTION, DIAGNOSTIC ANALYSIS AND SEISMIC IMPROVEMENT  
OF BUILDINGS DAMAGED BY SEISMIC EVENTS:  
S. MARIA ASSUNTA CHURCH AT FABBRICO (ITALY)****Armanasco, Alessandro<sup>1</sup>; Foppoli, Dario<sup>2</sup>**

Foppoli Moretta e Associati Consulting Engineers, Tirano (SO) ITALY

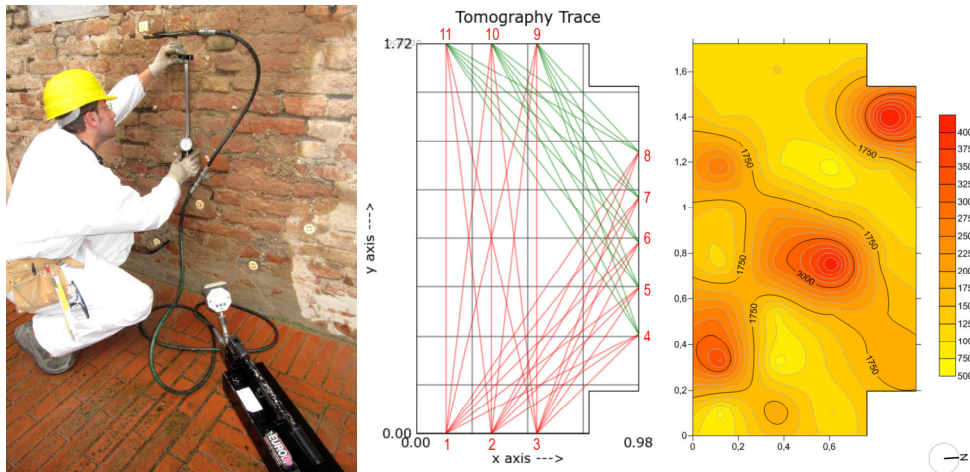
The mechanical properties of the materials, in particular of the masonry, have been determined, together with their state of stress, through flat jack tests (MDT) [3] [4] [5] (Fig. 2) which have been appropriately calibrated through the measuring of sonic wave velocities (NDT) [6] carried out extensively on the structure. Tomographic cross sections were drawn to analyse specific elements (Fig. 3). In order to fully identify the geometry of the masonry, the stratigraphy of the elevation and foundation structures were analysed by carrying out core drilling of small diameter which were subsequently inspected with an endoscopic probe. From the same cores, and from the surface in the accessible areas (to obtain undisturbed samples), the bedding mortars were sampled and subjected to chemical, physical and petrographic characterization.

Figure 2: Tests with flat jacks Figure 3: Tomographic horizontal section
