## Inspections and NDT for the characterization of historical buildings after seismic events: 2012 Emilia earthquake

**ABSTRACT:** Following the recent earthquakes that occurred in Emilia and Mantua areas (Italy) there was the necessity to inspect the damages, to characterize materials and structural elements and to evaluate the seismic behavior with reference both to the damaged and to the strengthened structures. A wide range of NDT methods were then applied to characterize masonry, timber and R.C. structures and also new test methods (for the measurement of masonry shear characteristics through flat-jack) were experimented, calibrated and applied during in situ operations. It is relevant that there was the possibility to perform the tests on buildings made with similar construction techniques, thus obtaining interesting comparative results.

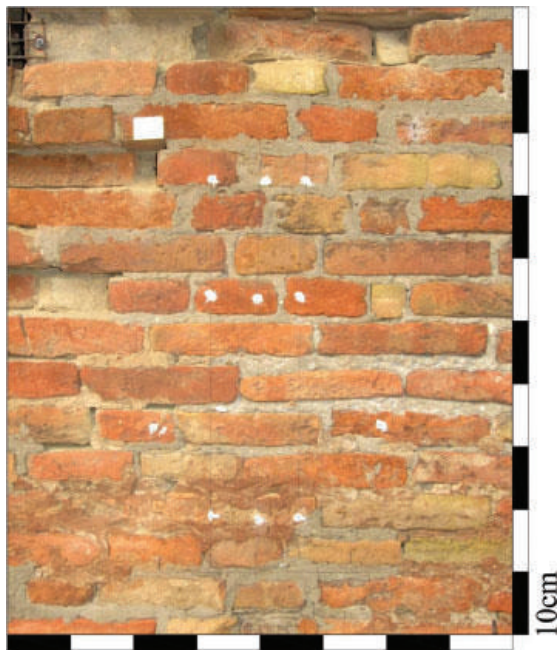
Figure 1. Texture of traditional brick masonry of Emilia region.

Masonry thickness usually ranges from 2 to 3 bricks dimension, that means from 24 to 38 cm and attention to masonry texture is usually quite close (Fig. 1): it

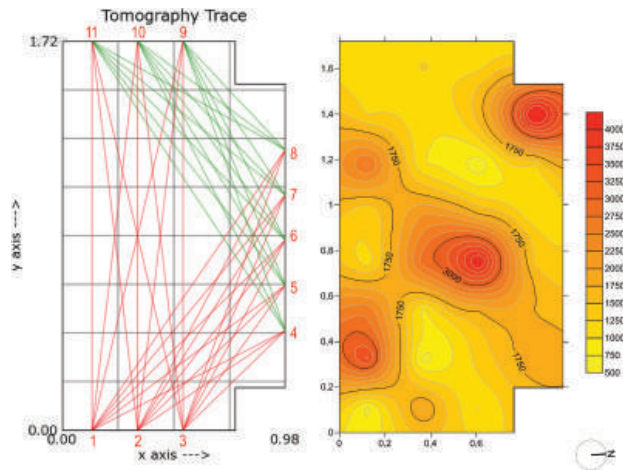
Figure 2. Sonic tomography of the horizontal section of a masonry pillar.

Some of the tests carried out were then processed using tomographic methods in order to evaluate the homogeneity of the masonry. In this case, the velocity measurements were repeated according to a dense grid of emission/reception points and according to a large number of paths; they were then processed obtaining tomograms showing the distribution of the velocity of longitudinal sonic pulses (Fig. 2).

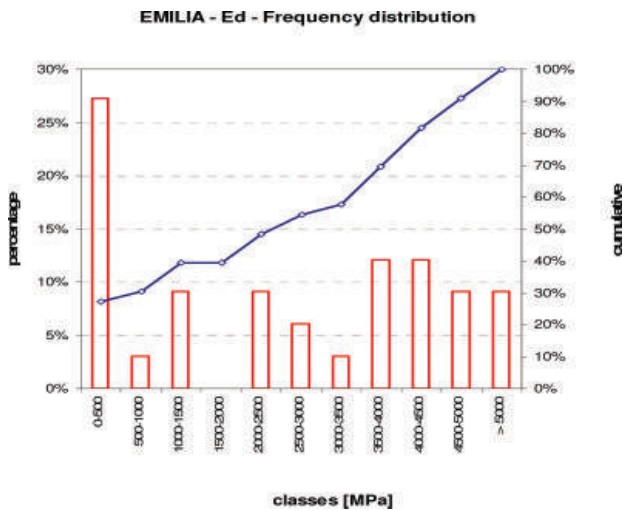
Figure 4. Emilia masonry: Young's modulus frequency distribution – percentage and cumulative frequency.

The frequency distribution diagram of the values  $E_d$  is plotted on figure 4. It clearly highlights how the values collected through in situ analysis are scattered, with an average of 2672 MPa; 30% of such values are under the level 1000 MPa (very soft masonry) and 30% are over the level 3500 MPa (very stiff masonry).

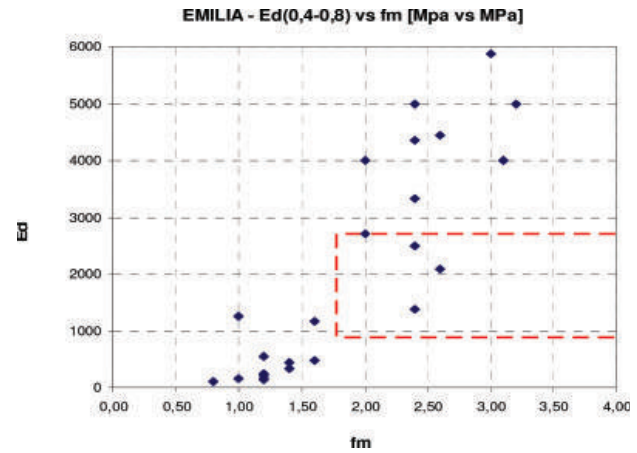
Figure 5. Emilia masonry: Young's modulus vs. compressive strength – results of in-situ tests compared with the range expected by the code (red dashed line).

The diagram that correlates  $E_d$  and  $f_m$  (Fig. 5) highlights that the relationship between the two parameters is not so significant ( $R^2 = 0.78$ ). In this diagram the

range of variation of the (average) reference values provided by the seismic code was plotted with red dashed lines: it is possible to observe that in most cases the measured values are outside the range expected by the code. This is more significant as it shows that many of the analysed brick masonry walls are less resistant than the values expected by the standards, and that there are also walls with stiffness greater than the value expected from the same tables.

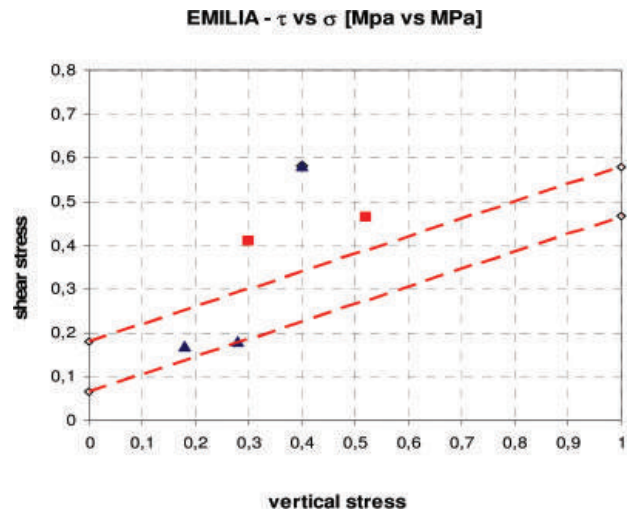
Figure 7. Coulomb's relationship between compressive stress and shear strength.

Figure 7 shows the results of tests carried out and the reference to Coulomb's relationship (2) defined on the basis of the limit values derived from the code, plotted with red dashed lines.

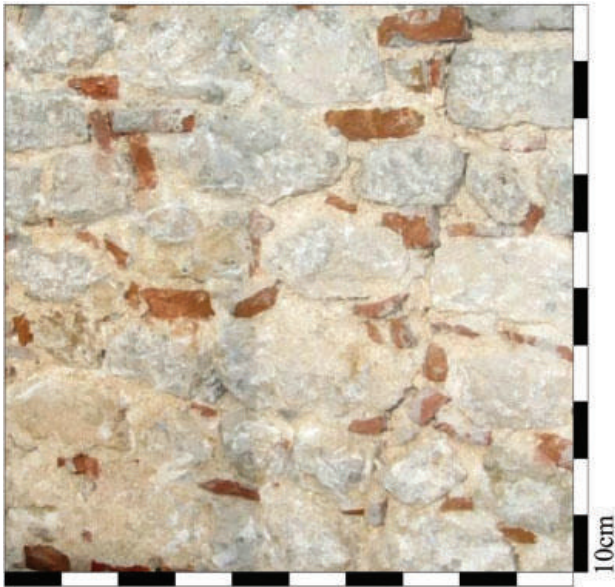
Figure 8. Texture of traditional brick masonry of L'Aquila historical centre.

The analysed historical buildings have masonry made with substantially similar characteristics: irregularly shaped limestone elements set in place with inaccurate techniques (Fig. 8). The most relevant category is described in the standard as "rubble stone disordered masonry", with elements irregular in shape, size, lito-type and material as further specified by other authors.

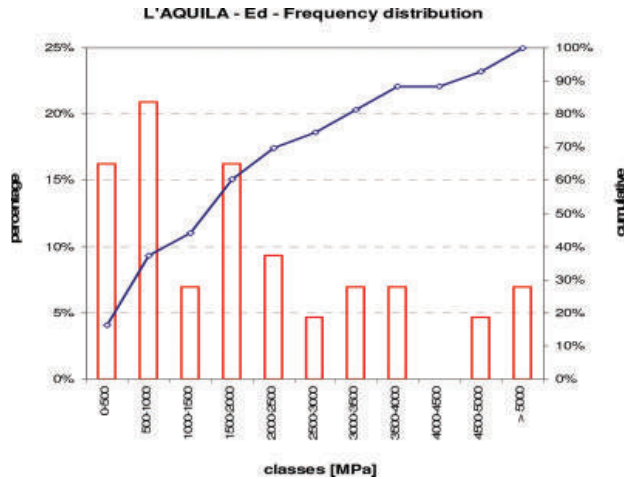
Figure 9. L'Aquila masonry: Young's modulus frequency distribution – percentage and cumulative frequency.

The frequency distribution diagram of the values  $E_d$  is plotted on figure 9 it highlights how the modulus values are less scattered than in the other case, with an average of 2248 MPa: about 40% of such values is under the level 1000 MPa (very soft masonry) and only less than 20% is over the level 3500 MPa (very stiff masonry).

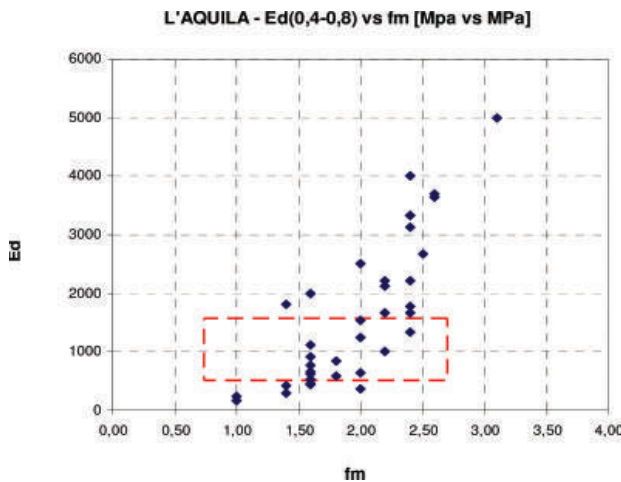
Figure 10. L'Aquila masonry: Young's modulus vs. compressive strength – results of in-situ tests compared with the range expected by the code (red dashed line).

The diagram that correlates  $E_d$  ed  $f_m$  (Fig. 10) highlights that also in this case the relationship between the two parameters is of little significance. In this diagram, the range of variation of the (average) reference values provided by the seismic code was also plotted with red dashed lines: it is possible to observe that in this case there is a better match with the values measured on site, although there are still a number of values placed outside the range defined by the code.
